Recording Archaeological Remains on the River Hamble

Final Report

June 2008

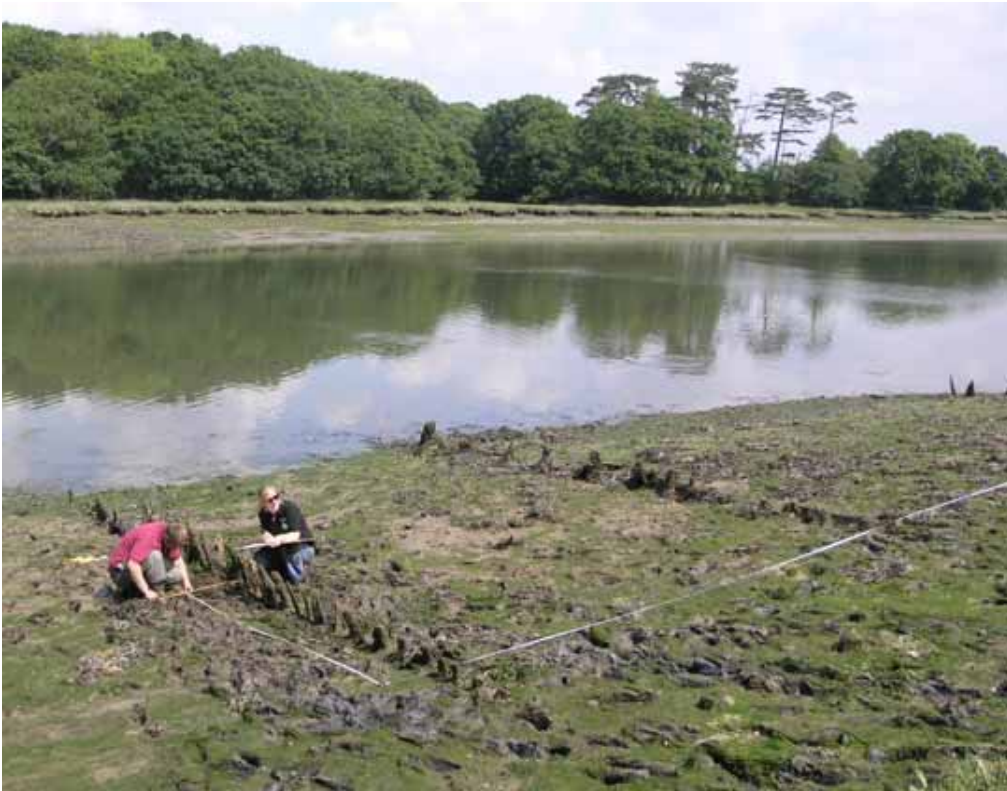
Figure 2 An intertidal site being recorded in plan by volunteers using the datum offset method

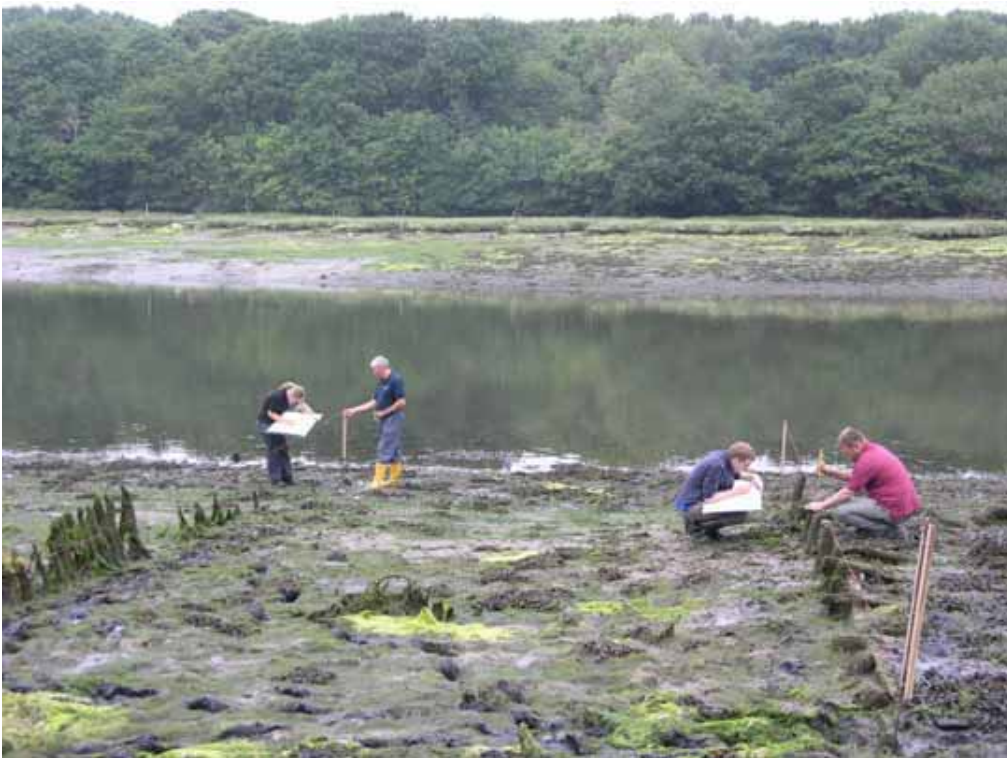
Figure 3 Volunteers recording site profiles of an intertidal site

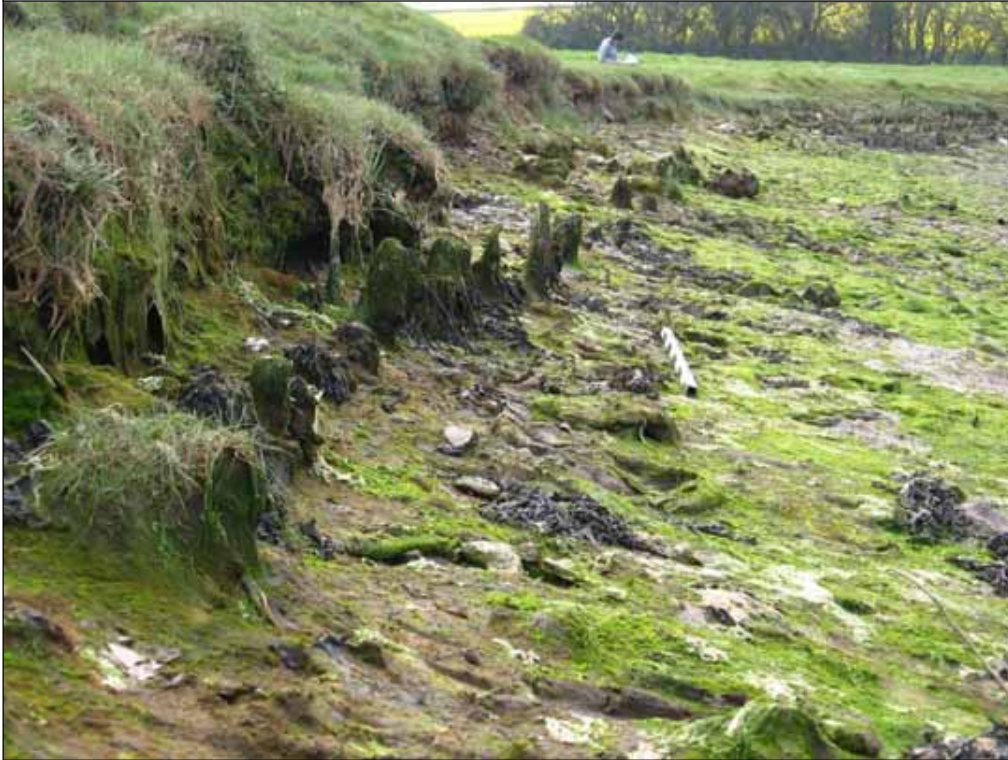
On the southern bank there are a number of irregular posts in an east-west alignment (groups 11 and 12) (HCC 42472). The heights are up to 0.3m, diameters between 0.02-010m and the alignments span a distance of 40m. The timbers of group 11 are vertical (Figure HAM002-2), while the timbers of group 12 are generally inclined to the northeast.

Figure HAM002- 2 Group 11 comprises of an alignment of timber posts located near the southern bank (Courtesy D. Hopkinson)

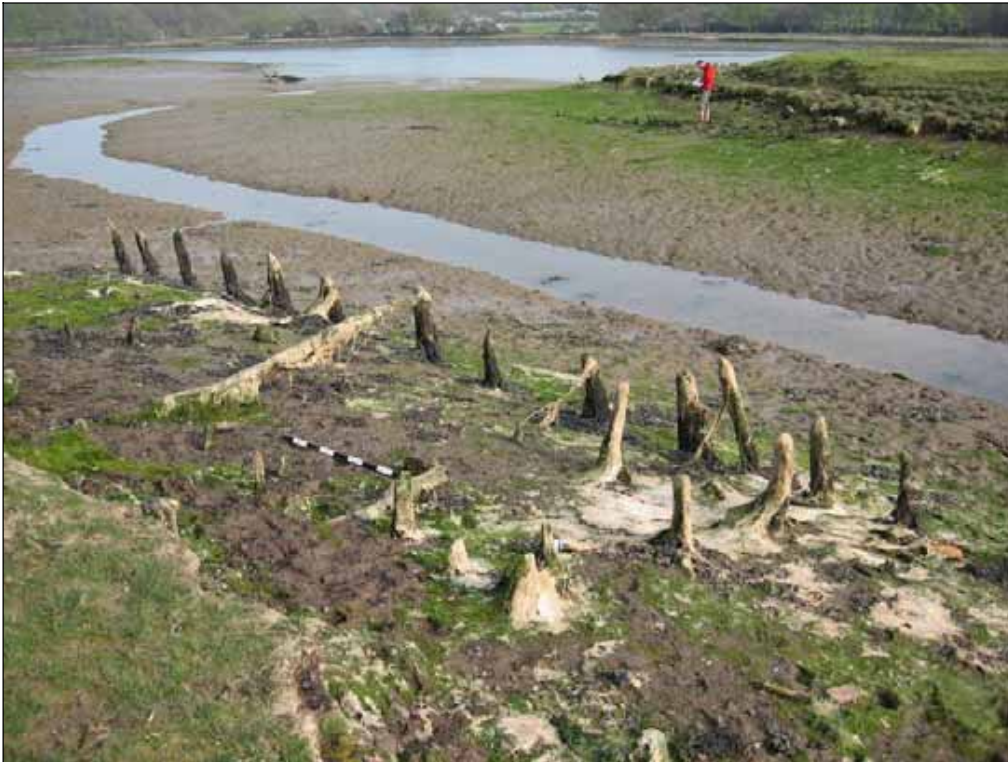
Mid-way along the creek on the north-western bank adjacent to the ford is a rectangular boxlike feature (Figure HAM002-3) (group 13) (HCC 42493). The dimensions of the feature are 14m by 3.8m, on an east-west orientation. The structure comprises of 22 visible upright posts that form the exterior of the box, with a further 25 posts within the interior, seemingly randomly distributed. A number of the interior posts have a steep rake of 30° from the horizontal. These interior posts may have helped consolidate the soils within the structure. No deck structure remains so it is unclear how the working surface area would have been situated.

Figure HAM002- 3 On the northern bank there is the remains of a box shaped structure (group 13) (Courtesy D. Hopkinson)

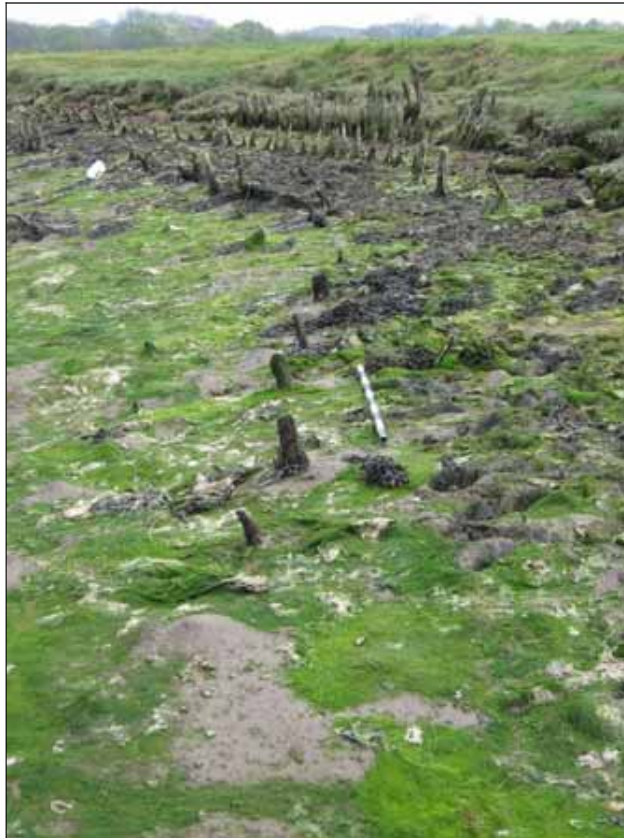
On the southern bank, where the creek bends towards the northwest a series of post alignments (groups 1 to 9), which follow the embankment, can be seen (Figure HAM002-4). With the exception of group 6 these features seem to form a larger structure of inter-leaved post alignments of similar construction. The tapering posts range from 0.07-0.12m in diameter, with an irregular or faceted cross-section. The posts near the bank are nearly vertical, while those further from the bank are inclined towards the water. These changes in inclination were observed as a gradual trend in this area, group 9 the furthest from the bank were steeply inclined at 20° from the horizontal. It is unclear if this trend is a product of construction, or the more probable gradual slumping of soils during use and decay which pushed the lower posts out of alignment.

Group 6 is different in construction from the others in the assemblage. It comprises of two groups of substantial posts aligned either side of an outflow pipe. Compared with the other posts in the area these posts have suffered less erosion, and their barkless surfaces are visible. However, there is some erosion with posts having thinned at the tidal line.

Figure HAM002- 4 Groups 1-9 are located on the southern bank and probably represent a number of structures (Courtesy D. Hopkinson)

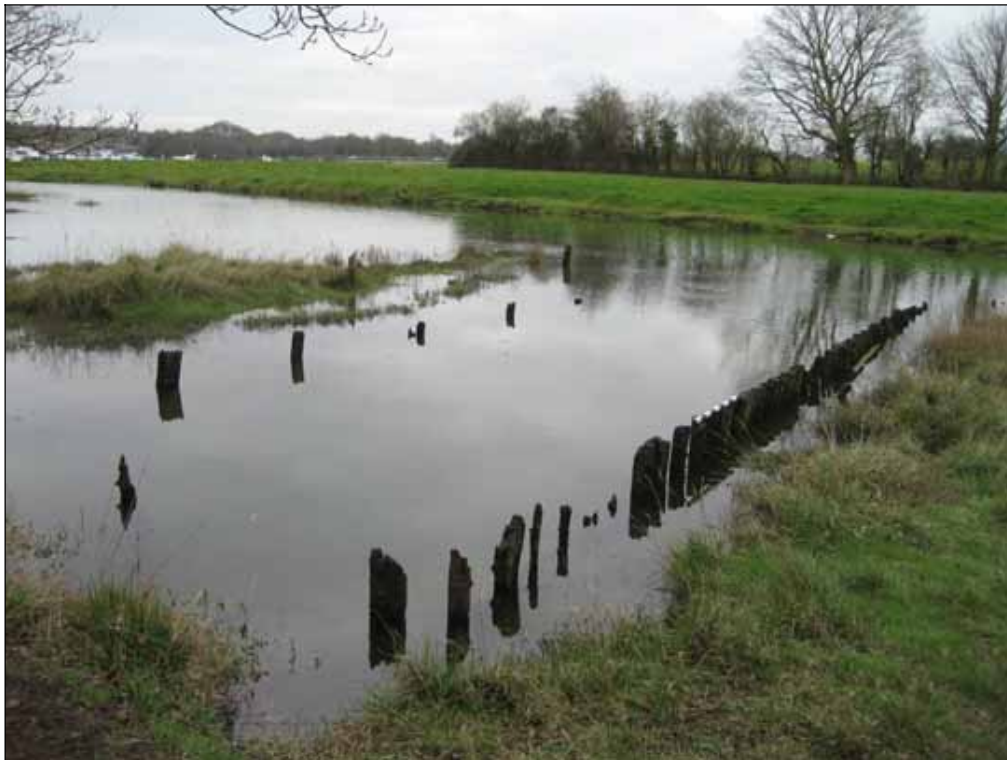
Group 16 is located at the north-eastern end and the return down the long south-eastern side. It is comprised of square posts, 3 along the short end and 6 visible ones along the long side, measuring 150mm x 100mm that are spaced approximately 2m apart (Figure HAM002-6). The posts appear to have been cut off at 1.30m above the mud, slightly higher than the high water mark, and during these periods the feature appears as short stubs of posts rising from the water. The posts are in generally good condition with some thinning at the tidal level (Figure HAM002-5). Just below the mud at ground level there are transverse timbers laid between the posts and the bank, although no evidence of fastenings can be seen.

Figure HAM002- 5 Groups 16 and 17 form a rectangular timber-lined dock area, the outline of which can still be seen at high water (Courtesy D. Hopkinson)

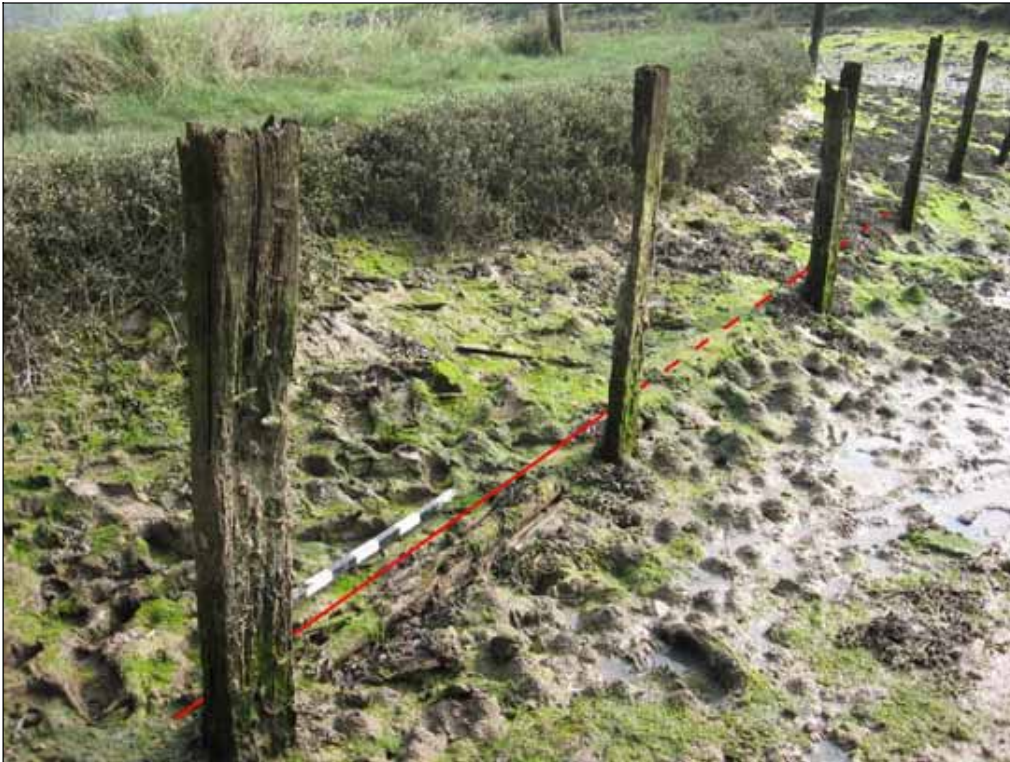
Figure HAM002- 6 The timber posts of group 16 have a regular spacing (Courtesy D. Hopkinson)

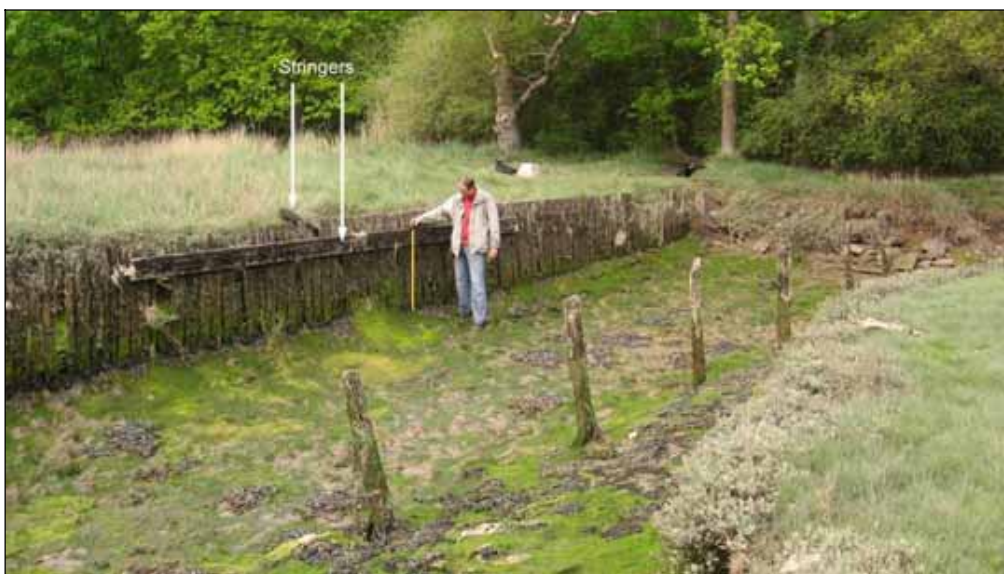
Group 17's structure is of lighter construction and is characterised by a dense arrangement of posts laid adjacent to each other as shuttering; they are in varying states of repair (Figures HAM002-7 and 8). The timbers used in the structure are fairly consistent and have dimensions of 150mm x 80mm. Two horizontal stringers were observed, one on the inside of the bay and one on the reverse. These elements are connected using metal fastenings. These timbers form a revetment the face of which is irregular. Where the remains are in a poorer condition there are fewer posts remaining and no surviving stringers.

Figure HAM002- 7 The remaining structure of group 17 is different from group 16 and the posts are very close to each other (Courtesy D. Hopkinson)

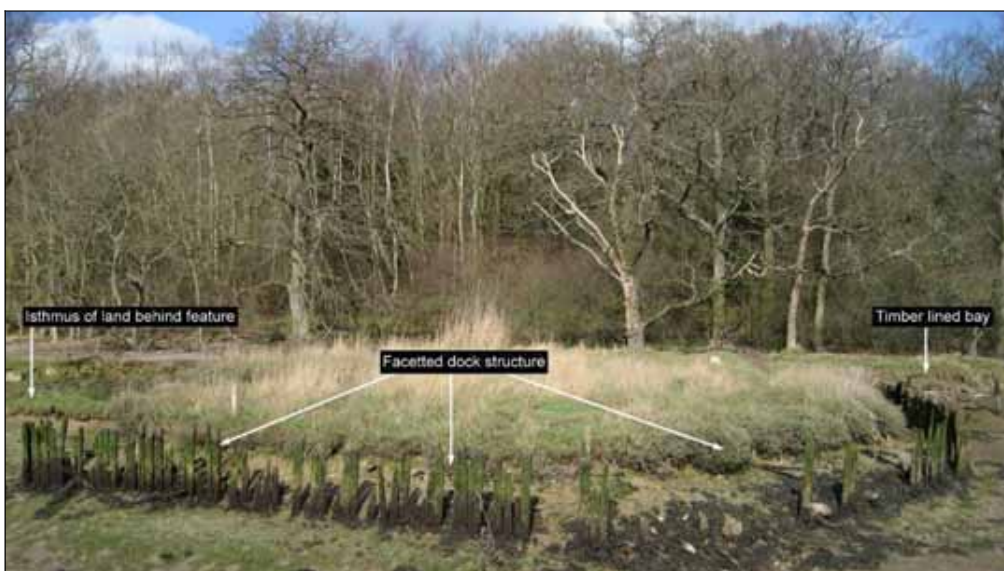
Figure HAM002- 8 The posts form a revetment of varying states of repair surrounding an earth promontory (Courtesy D. Hopkinson)

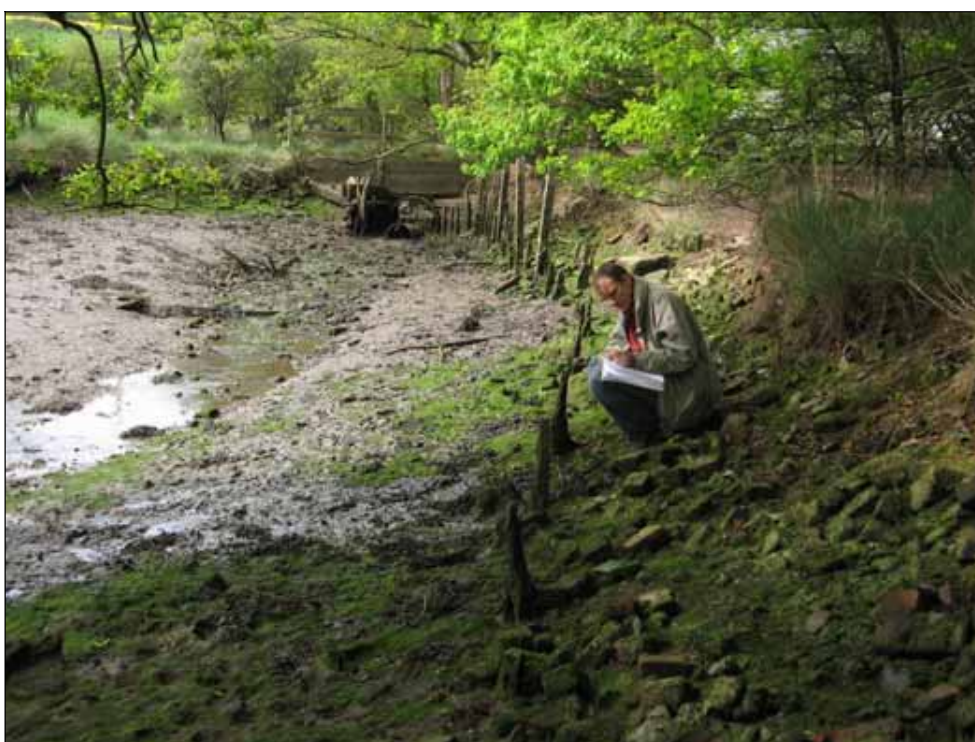
Located at the northwest extremity of the creek are groups 18 and 19. Group 18 (HCC 42490) is an alignment of irregular tapered posts; these posts are in a poor condition. The posts measure up to 0.10m in diameter and have a

spacing of approximately 1.3m. The alignment runs from a bank in a north-westerly direction for 15m, after which there is a dogleg and the alignment carries on in a west-north-west direction for a further 15m until it meets the footbridge (group 19) (Figure HAM002-9). There is an additional post alignment in front of the final stretch of this feature consisting of 15 substantial posts with rectangular cross-sections. Between these two post alignments, near the bridge, a further small section of irregular tapered posts can be found. Behind the post alignments the bank of the creek is made up of discarded building material such as tiles and brick rubble. A typical brick was recorded, measuring 0.24 x 0.11 x 0.06m with a small frog, and is likely to have been handmade in a sand mould. With visual assessment only it can be dated to anywhere between the 17th to 20th century, although a late 18th to early 19th century date has been suggested (Mills pers. com. Jun 2007).

Figure HAM002- 9 Group 18 runs up to the bridge (group 19) and has a clearly definable dog-leg (Courtesy D. Hopkinson)

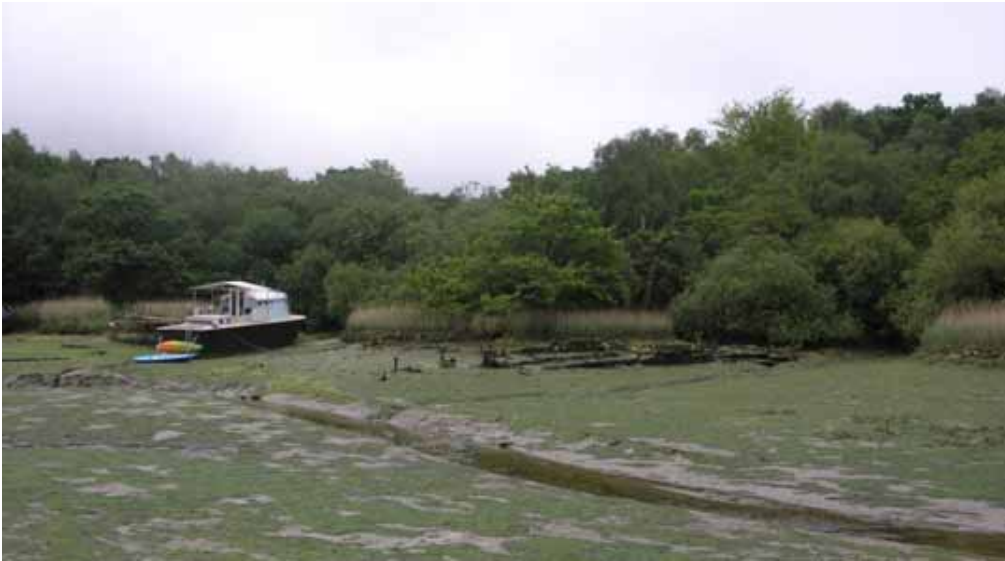
Figure HAM007-1 In Badnam Creek lies the remains of the Thames Sailing Barge 'Five Sisters'

This abandoned wooden hulk lies in a northeast-southwest orientation. The vessel is in an advanced state of decay and very little can be seen above the sediments. The estimated dimensions of the visible remains are approximately 30m in length by 6m wide. An impression of the hull outline can be seen, and around midships, on both sides, a section of the hull rises above the sediments to about 0.5m. Some of the internal construction components are visible, but it was not possible to make out what these may be from the opposite bank. It was also not possible to define the bow or the stern.

It was not possible to complete a drawn survey of this site, however it can be suggested that there is not a requirement to do so as much is known about this vessel from the research conducted. If a safe method of access can be arranged, the recommendation would be for an in-depth photographic survey to be completed. This would give an indication of how much of the vessel remains and may help gauge the rate decay.

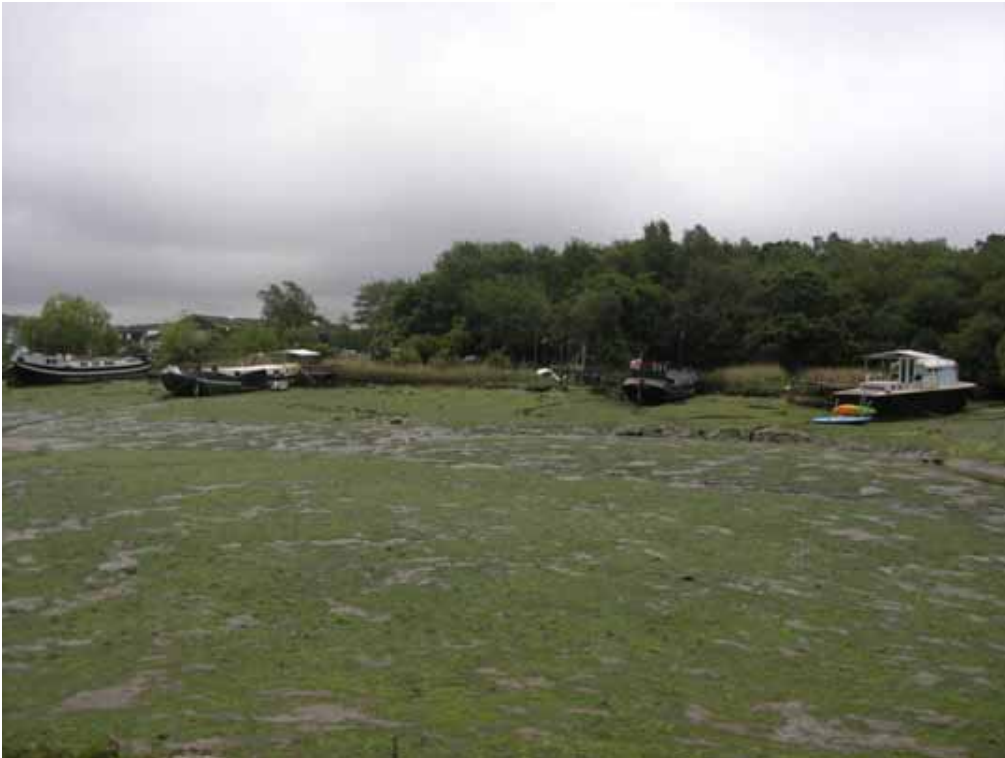
Figure HAM007-2 - Prior to 'Five Sisters' being moved to its current position it was used as a houseboat and was berthed in the mud berth second from the right

Local people were visited and questioned about their knowledge of the hulks that can be found in Badnam Creek. This proved to be a fruitful route of enquiry. Local resident and former Badnam Creek houseboat owner Katy Bewes indicated that this is the remains of a Sprit Sail Thames Sailing Barge 'Five Sisters'. According to the Society for Sailing Barge Research (1996), the *Five Sisters* was constructed by Wills and Packham of Sittingbourne in 1891. The barge was used by the family of Tom and Peggy Larken as a houseboat, until it fell into disrepair (Figure HAM007-2). Once the vessel was abandoned it was moved from its previous position in a mud berth 50m to the south, to its current location. It is believed the barge was deposited above the remains of either an LCA or an Admiralty Motor Launch. Once in this position the 'Five Sisters' was burnt.

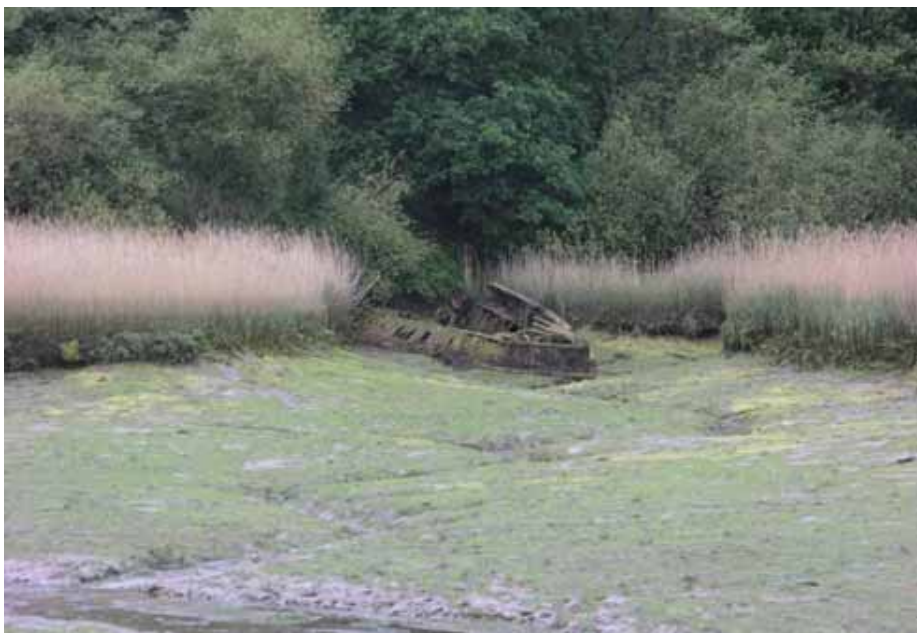
Figure HAM008-1 - The remains of the former ferry 'Sandringham' lies in the tidal mud of Badnam Creek

From the opposite bank the stern is visible and points toward the northeast. A large amount of the hull remains, although this has collapsed in sections and is buried up to the wale. The wale runs around the vessel below what would have been the deck level. The decking was wooden and this has almost completely collapsed. Above the deck there are the remains of the bulwark and its plating, some of this plating has corroded leaving a number of holes. The stern, a 'cruiser' type, is the most preserved section of the vessel. Around the stern the vessel's name, *Sandringham*, is just visible. The hull is *in-situ* around the quarterdeck, however, it has collapsed forward of the starboard quarter. Two bollards can be seen upright on the port and starboard quarters. The forward half of the vessel is obscured by vegetation and none of the superstructure could be seen.

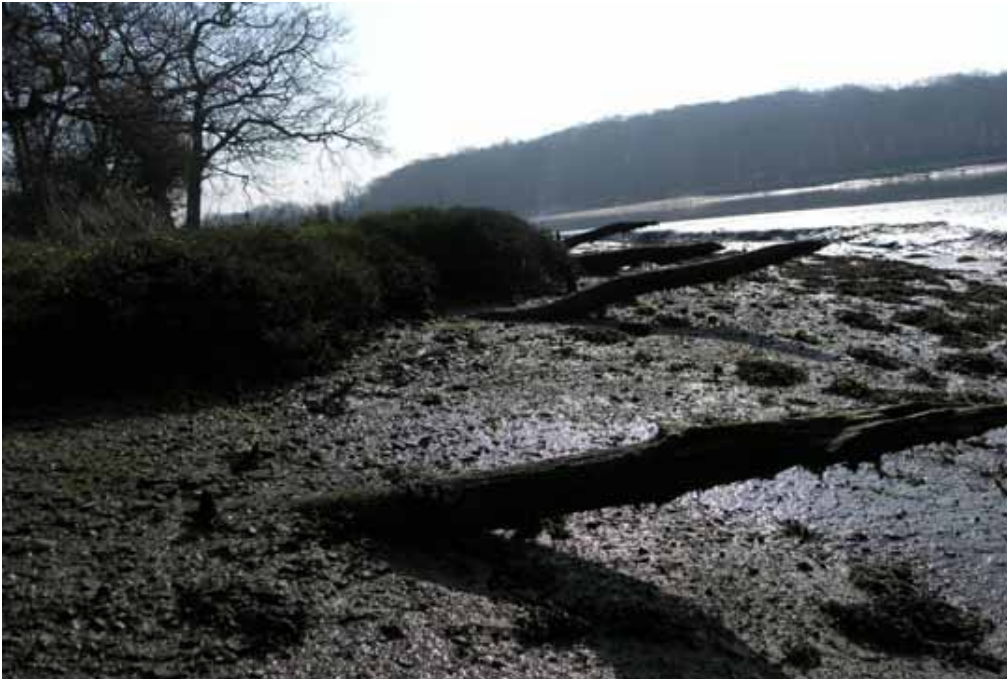
Figure HAM010 - 4 HAM 009 consists of five horizontal timbers protruding from the eastern bank to form part of a wharf or hard

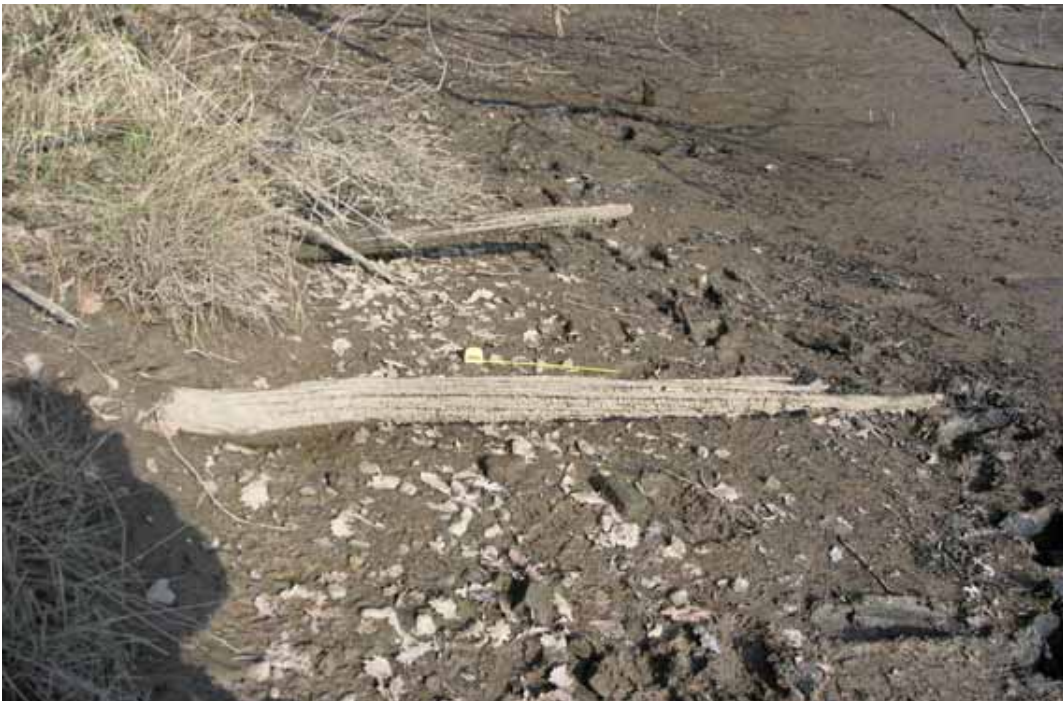
Figure HAM010 - 5 HAM 011 forms the wharf or hard on the western bank where the timbers are more decayed and the revetment less obvious

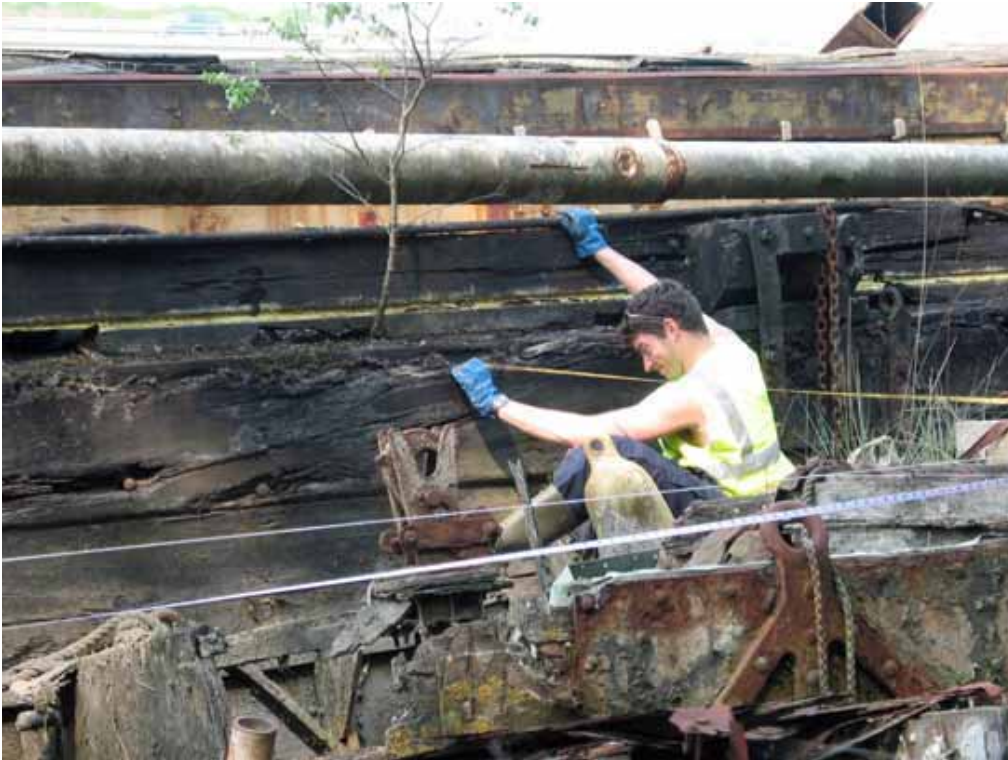
Figure HAM017- 1A student using the datum offset method of recording in somewhat uncomfortable conditions

A baseline was created and the vessel was recorded using the datum-offset method (Figure HAM017-1). From the survey it was possible to record the longitudinal profile, nine hull section profiles and the starboard side of the transom (Figure HAM017-2). The vessel is predominately symmetrical, so the starboard gunwale was surveyed in plan to give an indication of the complete hull shape.

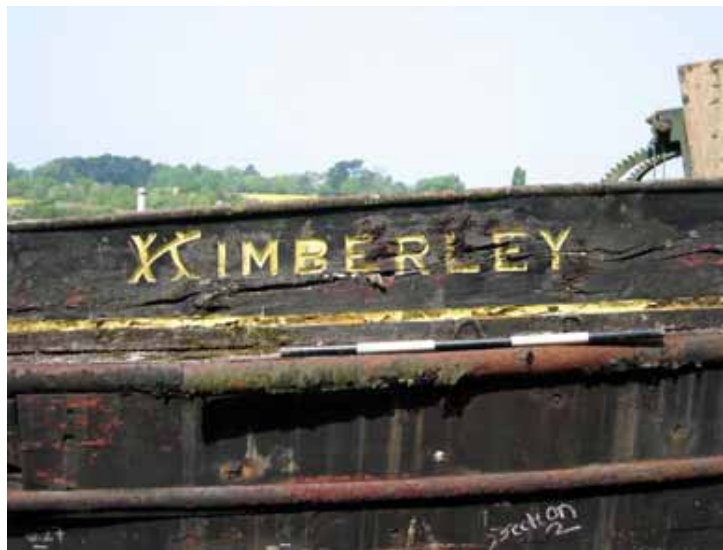
Figure HAM017- 3 The name *Kimberley* is engraved in to the Bulwark above a thin yellow stripe of decoration

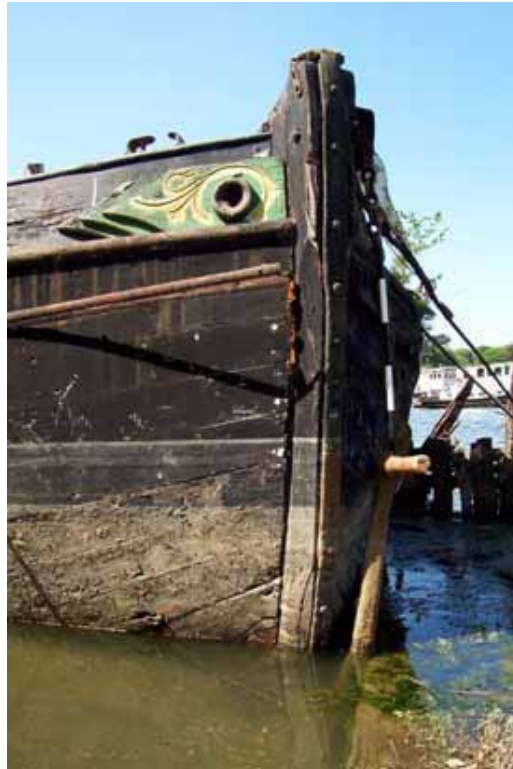
Figure HAM017- 4 Bow view with decoration around the hawse holes clearly visible

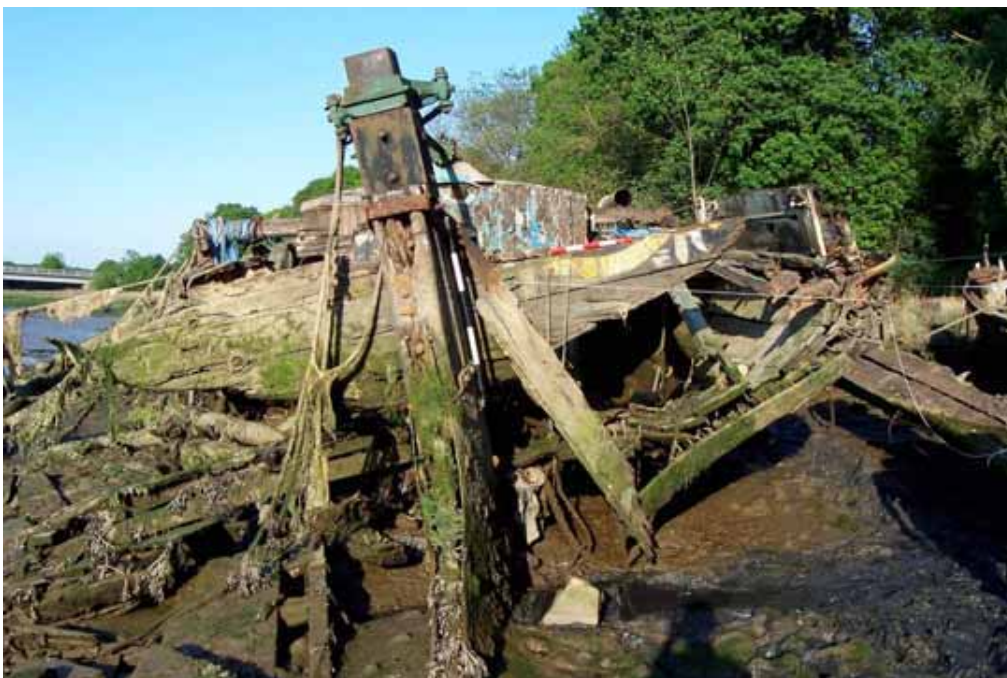
Figure HAM017- 5 View of the collapsing transom, with the faded name and the home port of 'Ipswich' clearly visible

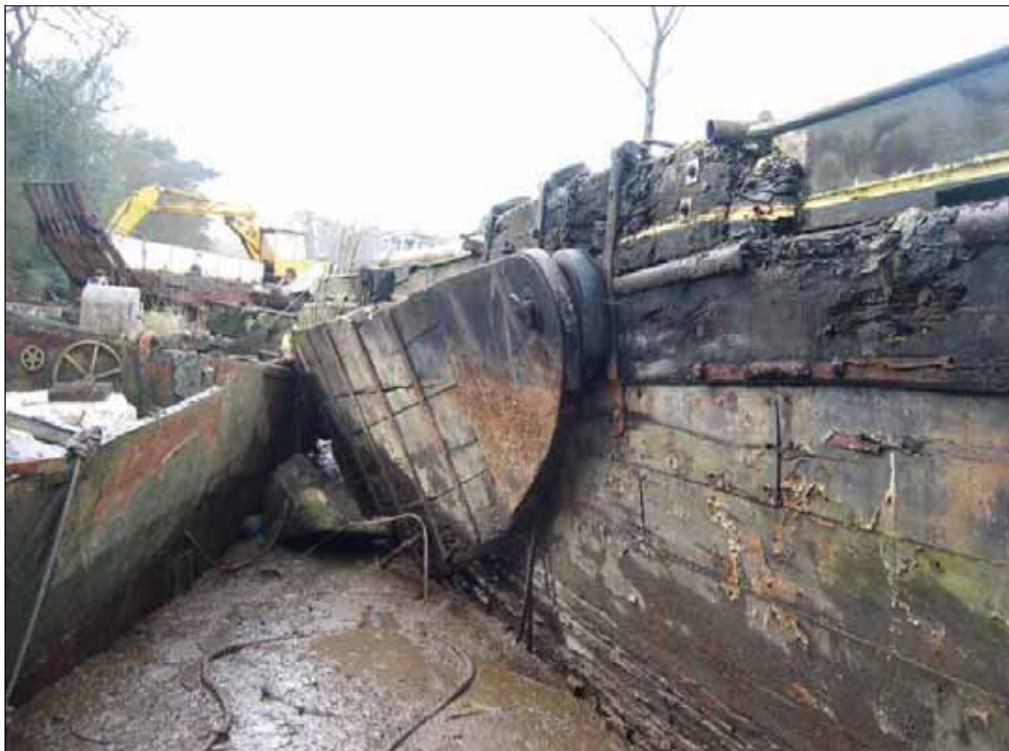
Figure HAM017- 6 Photograph of the starboard leeboard

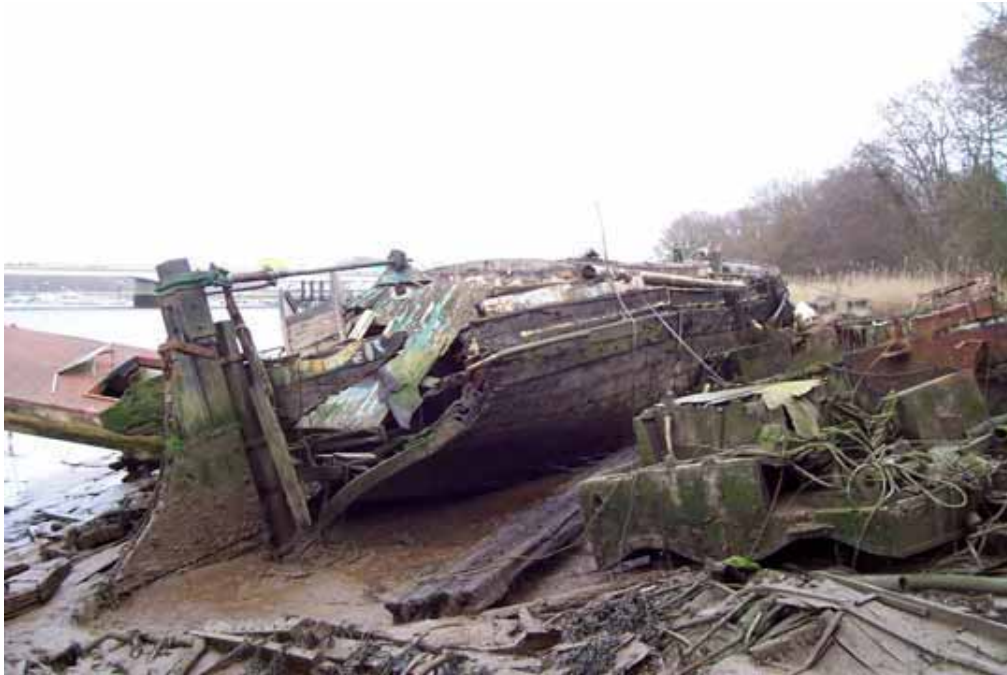
Figure HAM017- 7 The transom stern of HAM017 has collapsed (looking north)

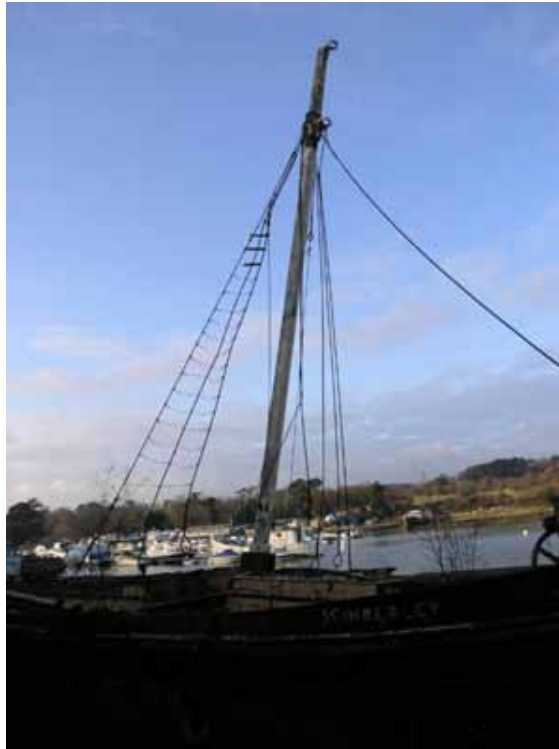
Figure HAM017- 8 Photograph of Kimberley taken in 2005 with the main mast still in an upright position

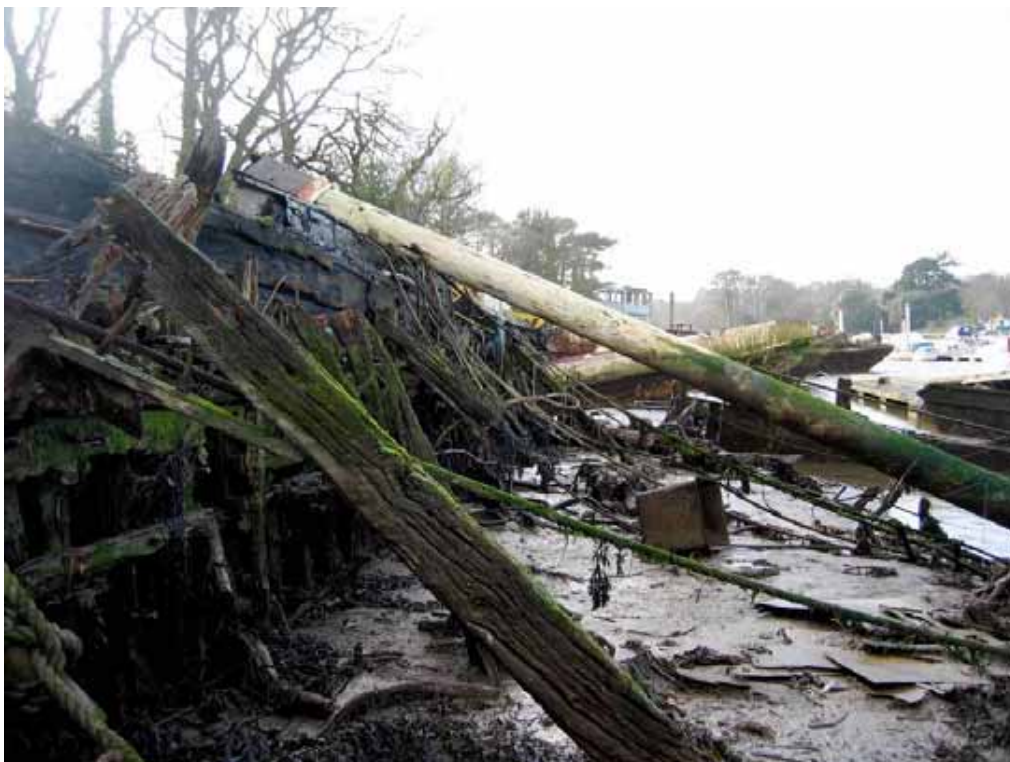
Figure HAM017- 9 Photograph taken in 2007 with the collapsed mainmast lying off to the portside

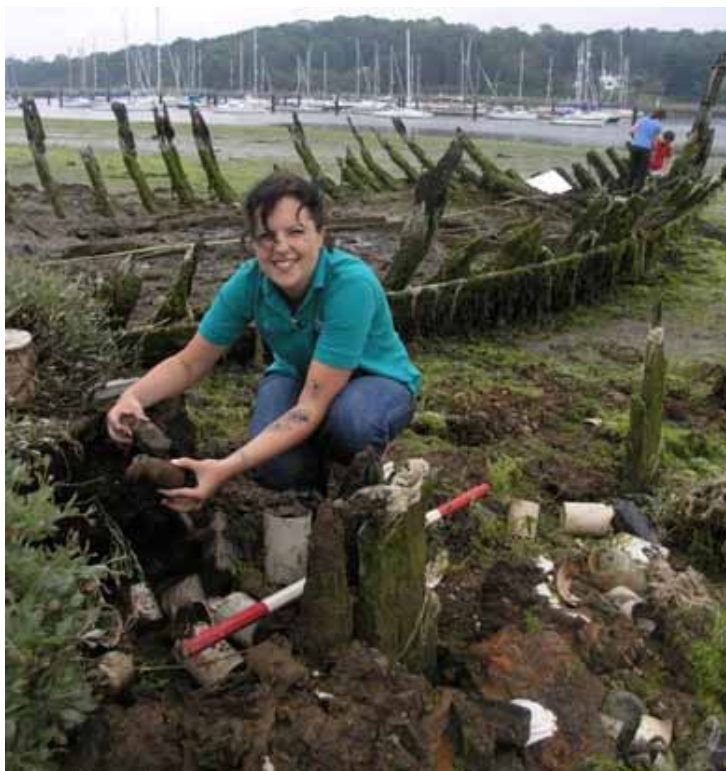
Figure HAM051- 1 The remains of HAM051 cuts through an embankment containing a lot of refuse and debris

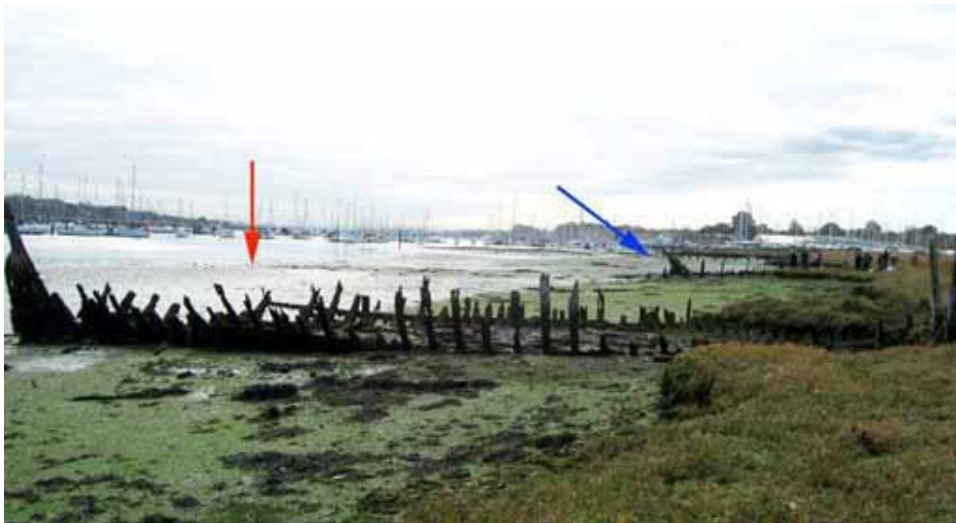
Figure HAM051- 2 The remains of HAM051 (red arrow) with HAM037 in the background (blue arrow). The embankment can be seen on the right of the photograph (looking south)

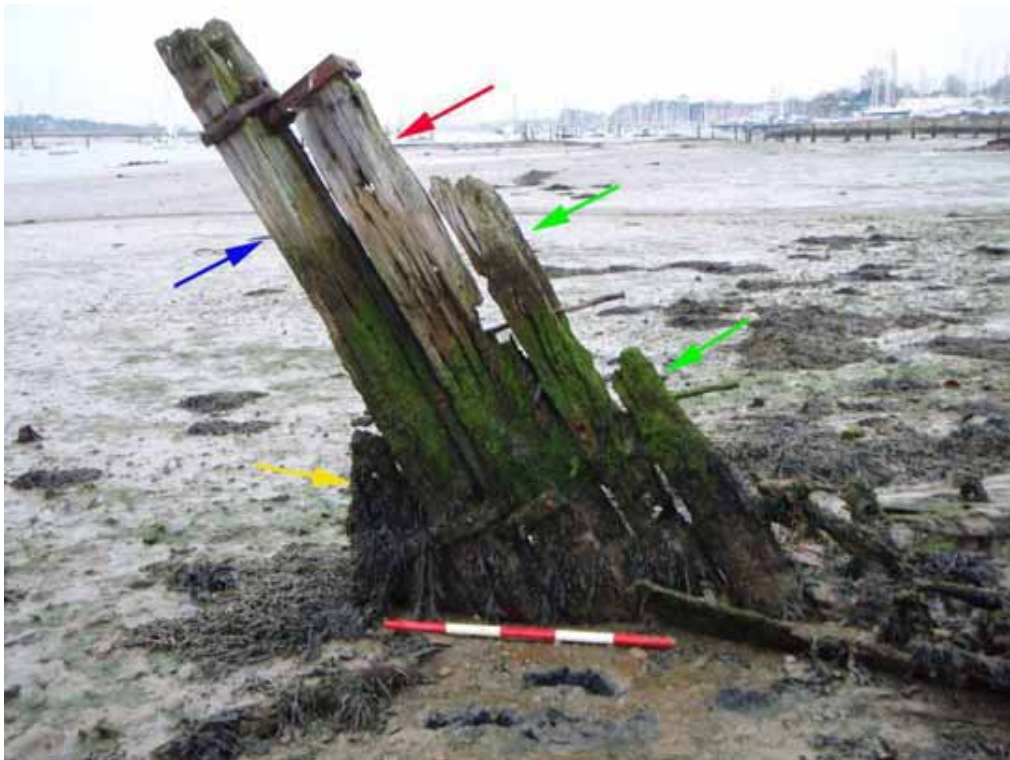
Figure HAM037- 3 The stern of HAM037 with the Sternpost (red arrow), rudder stock (blue arrow), inner posts (green arrows) and a section of rudder (yellow arrow) indicated (looking south)

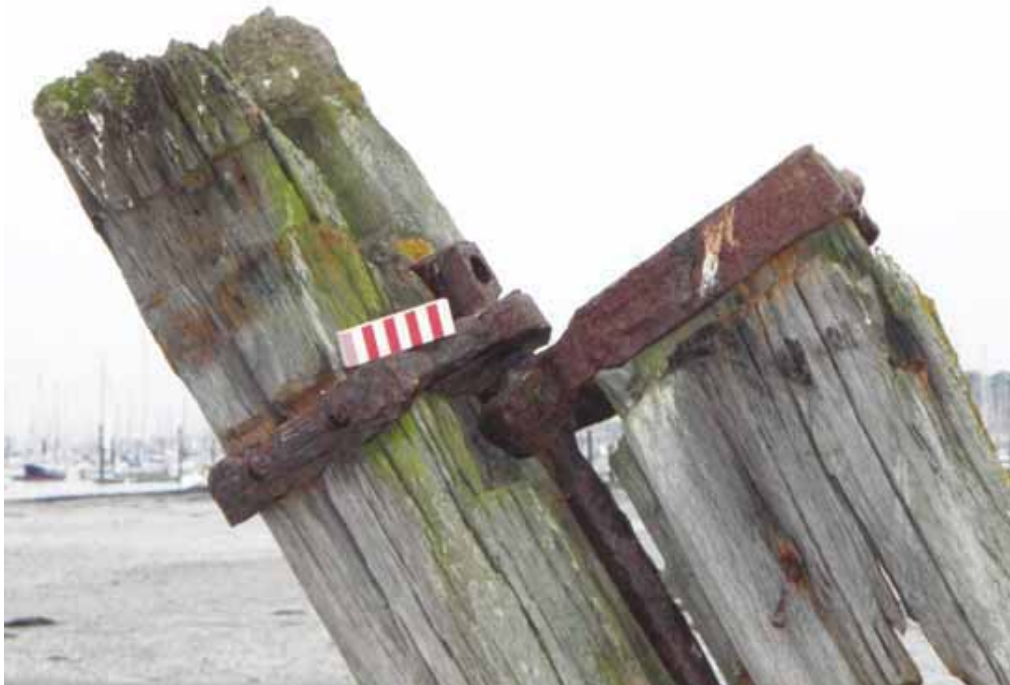
Figure HAM037- 4 The axel of the rudder comprises of a pin with a bracket fastened to the sternpost and the rudder stock (looking south)

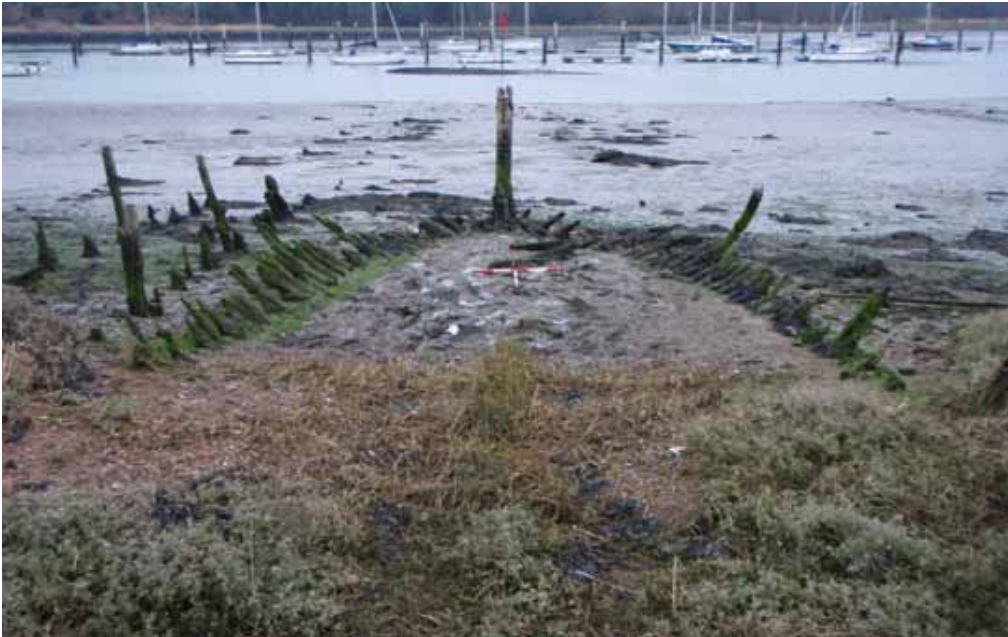
Figure HAM037- 5 The outline of HAM037 is marked by the frames (looking east)

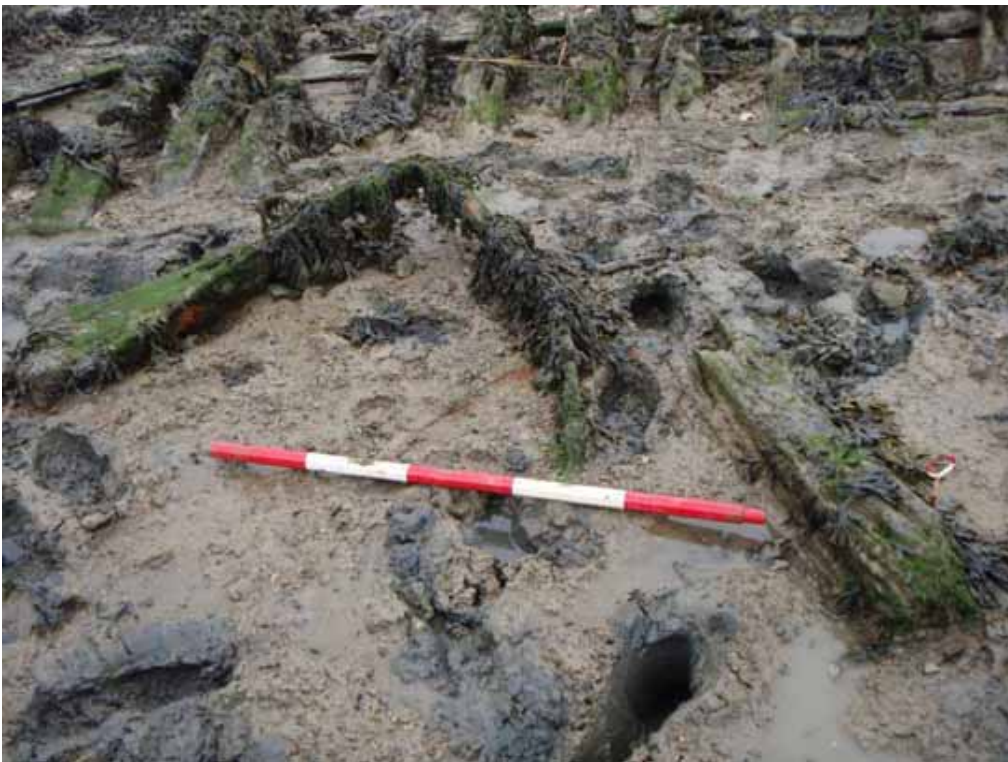
Figure HAM037- 6 A disarticulated metal knee with a section of a deckhead beam attached

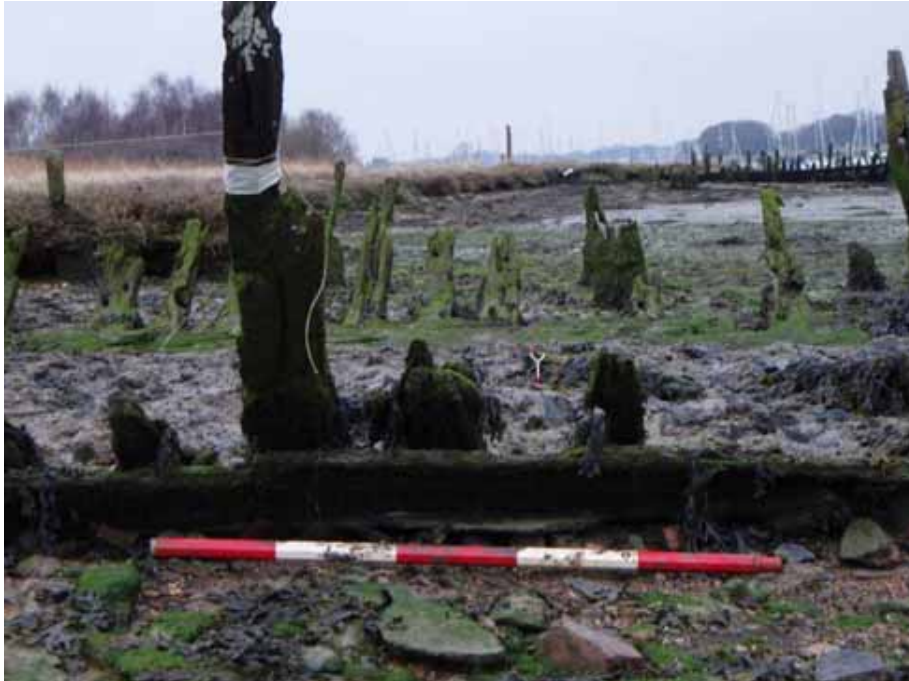
Figure HAM037- 7 A section of hull planking on the port side. It can be seen on this photograph that scouring beneath the vessel is occurring (looking north)
