Recording Archaeological Remains on the River Hamble

Final Report

June 2008

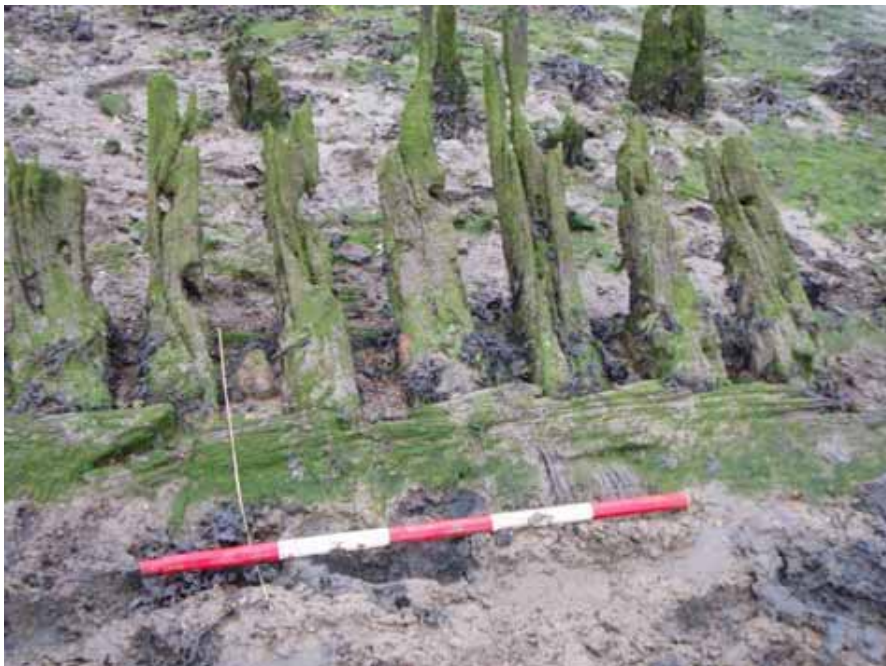
Figure HAM037- 8 A section of the starboard hull with the inner ceiling planking clearly visible (looking north)

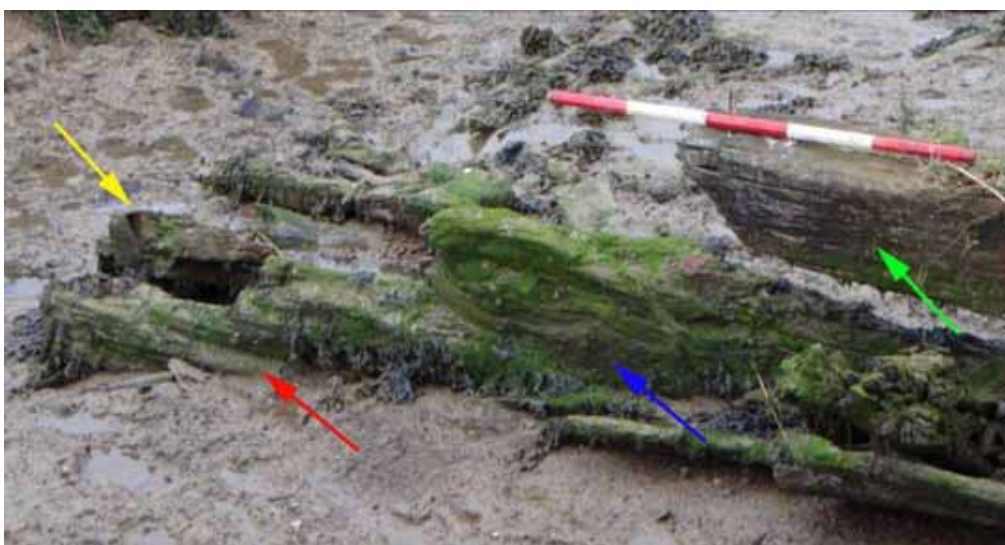
Figure HAM037- 9 The bows with the keel (red arrow), the deadwood (blue arrow), the keelson (green arrow) and the collapsed section of the stempost (yellow arrow) indicated (looking north)

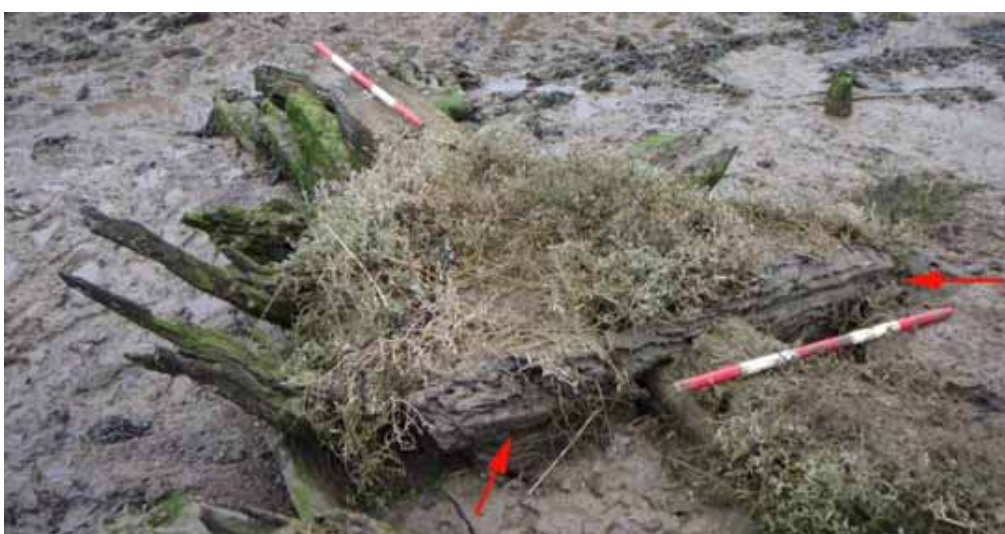
Figure HAM037- 10 The bow section of HAM037 with the concrete ballast indicated (looking northwest)

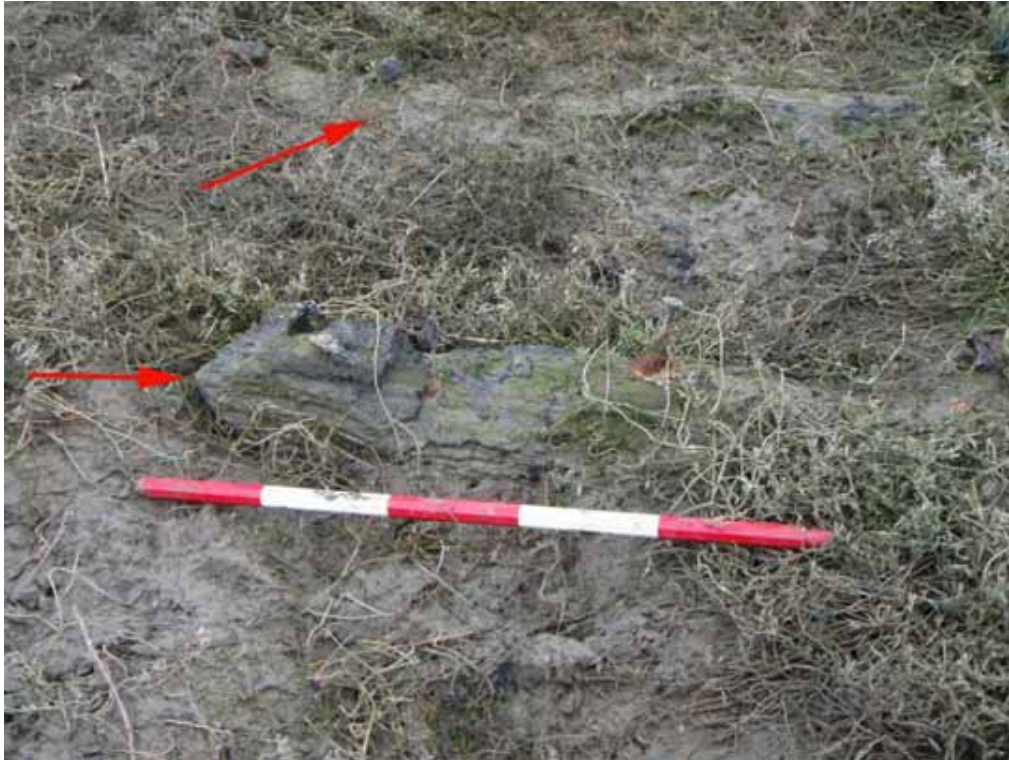
Figure HAM037- 11 Two of the athwartships timbers (looking west)

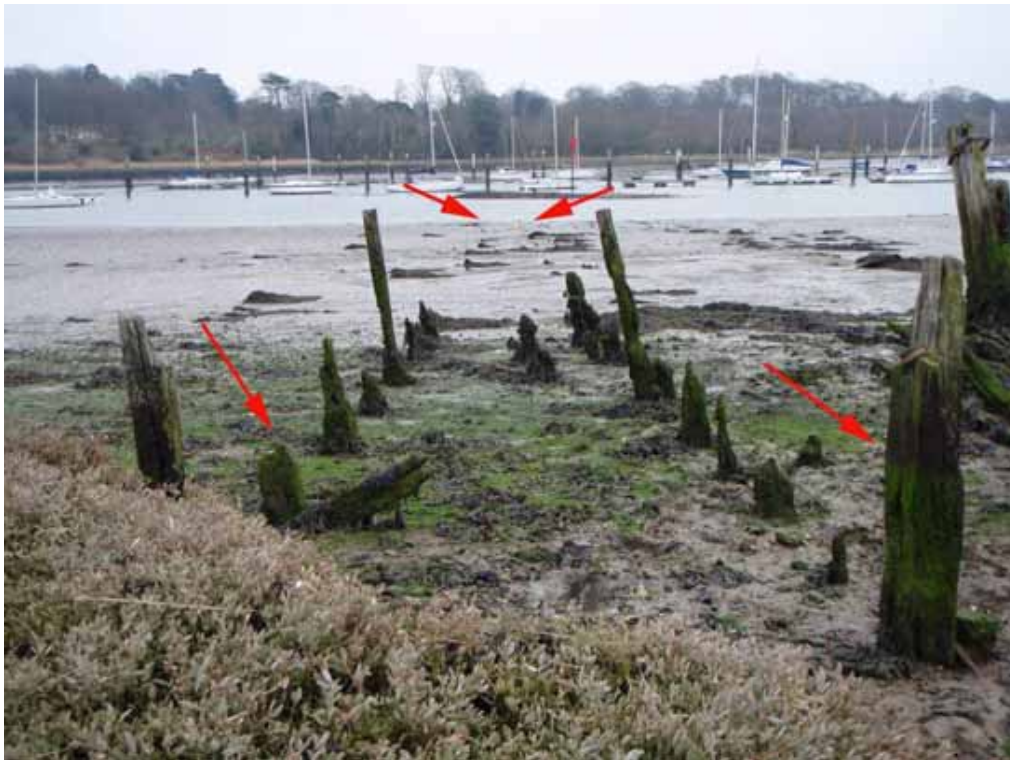
Figure HAM037- 12 The remains of a jetty on the starboard side of HAM037 (looking east)

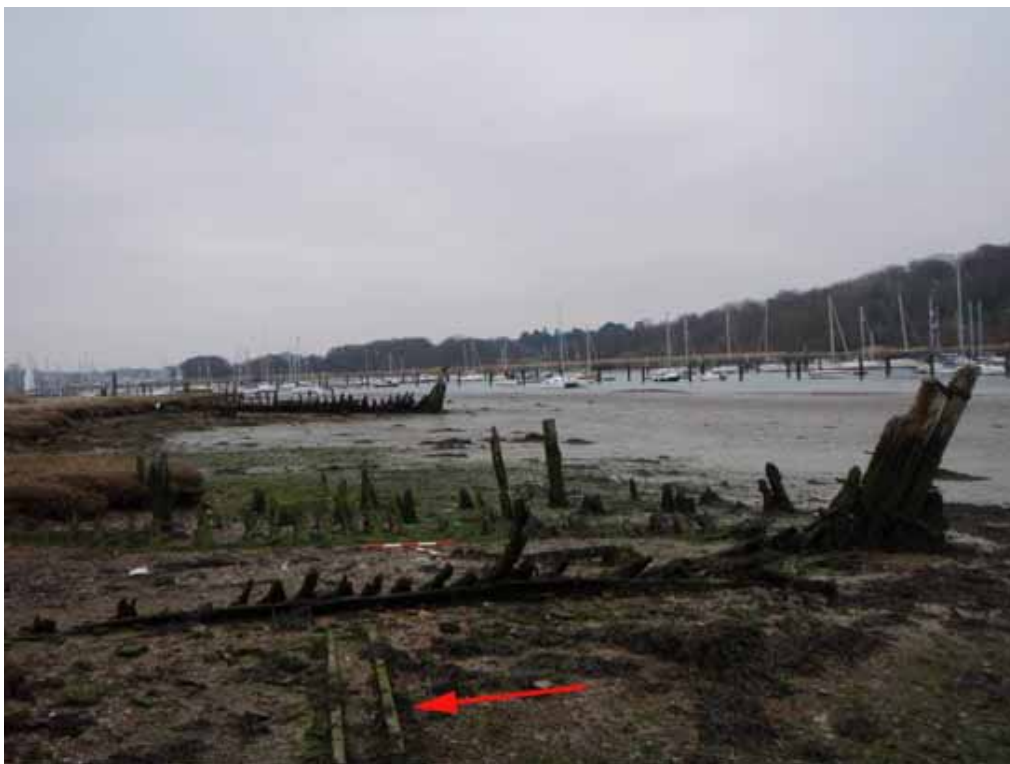
Figure HAM037- 13 On the portside of the vessel is the remains of a drain (looking north)

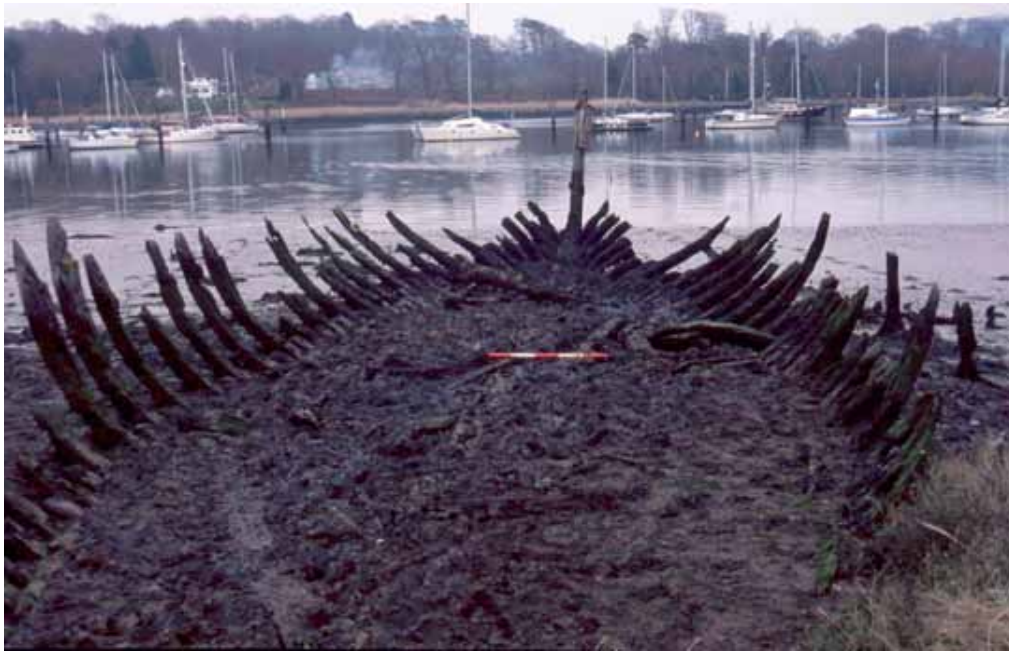
Figure HAM051- 3 HAM051 looking aft where the frames and sternpost can be clearly seen. The centre of the hull and the bilges are buried beneath sediments (looking east)

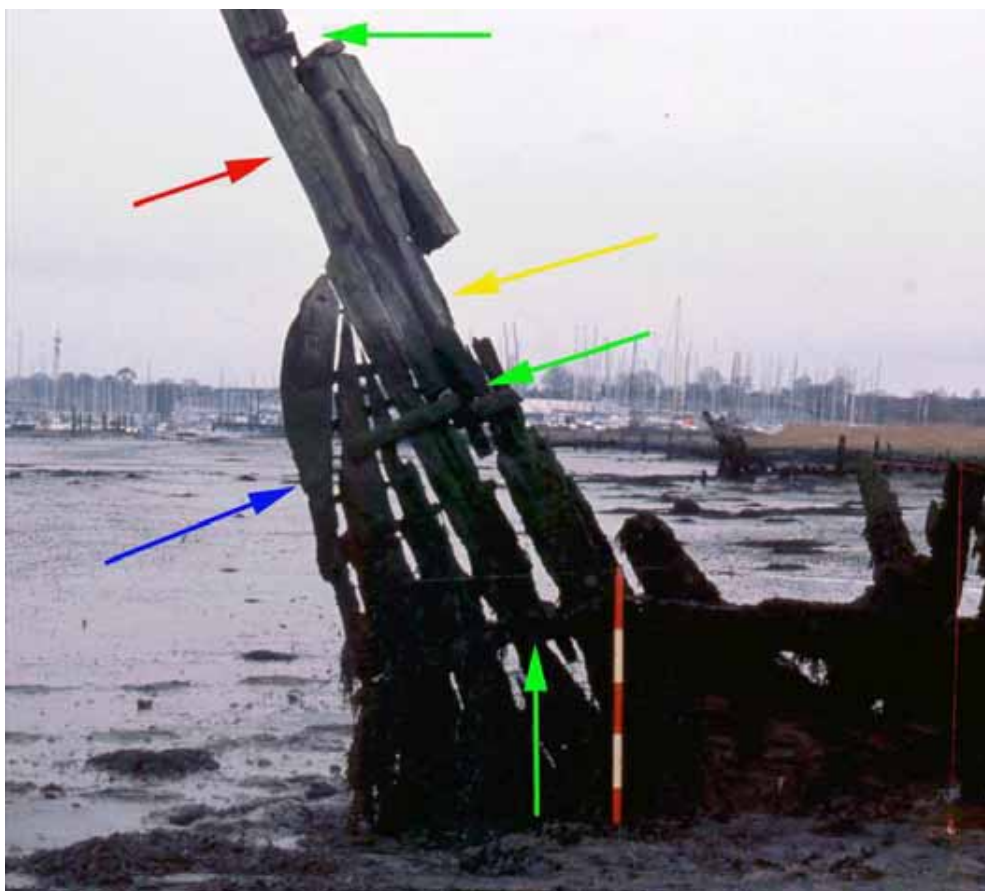
Figure HAM051- 5 The stern with the rudder stock (red arrow), rudder timbers (blue arrow) pintles and gudgeons (green arrows) and the sternpost (yellow arrow) indicated (looking south)

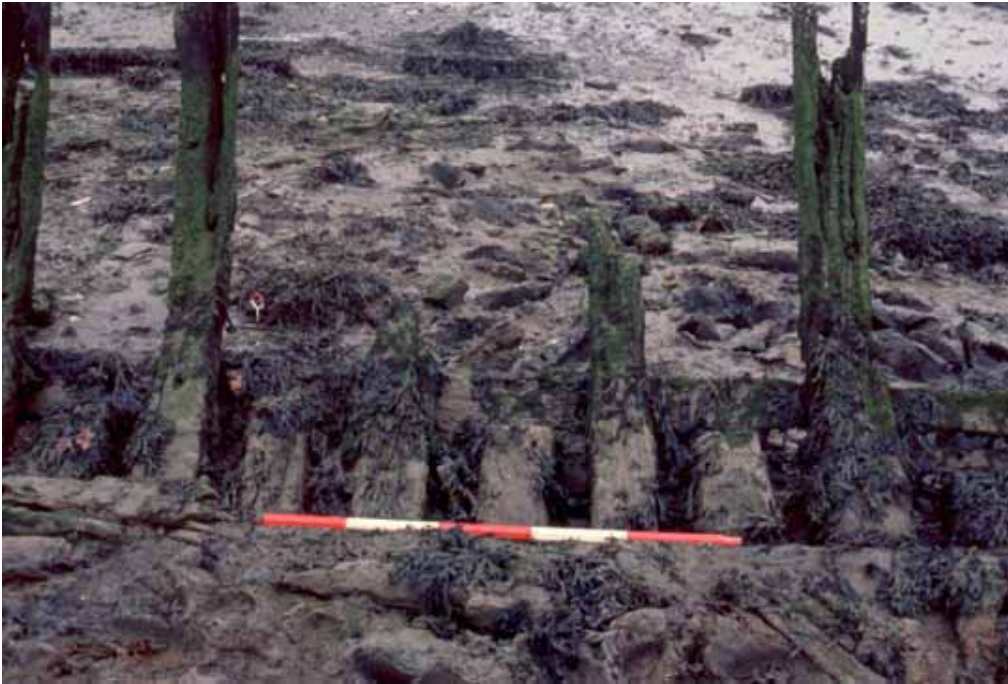
Figure HAM051- 6 The remaining frames have been broken off or eroded to different heights (looking north)

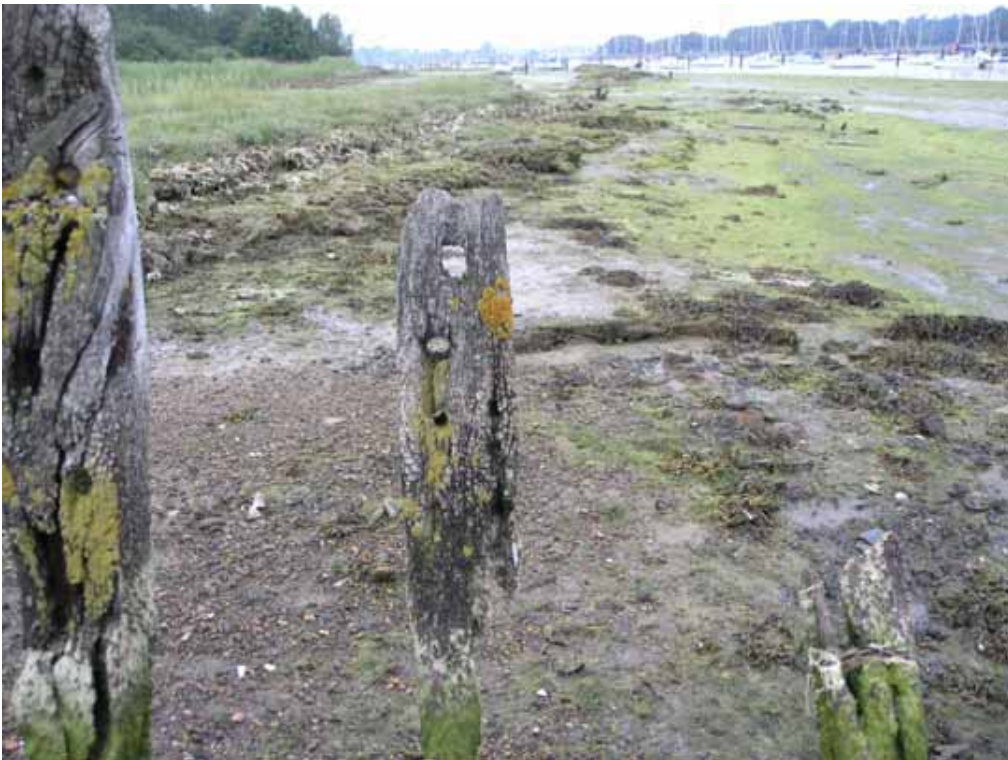
Figure HAM051- 7 The upper part of this frame lies above the high tide and is less eroded than the timber that lies within the tidal range

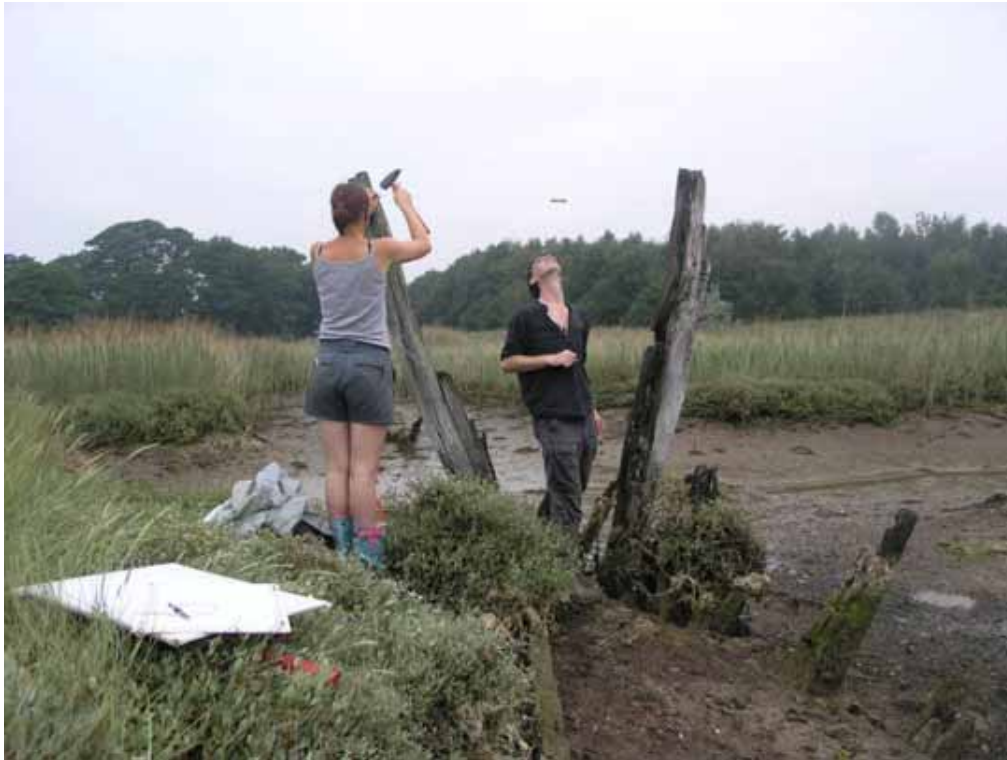
Figure HAM051- 8 Volunteers recording the two tall frames located at the bow (looking west)

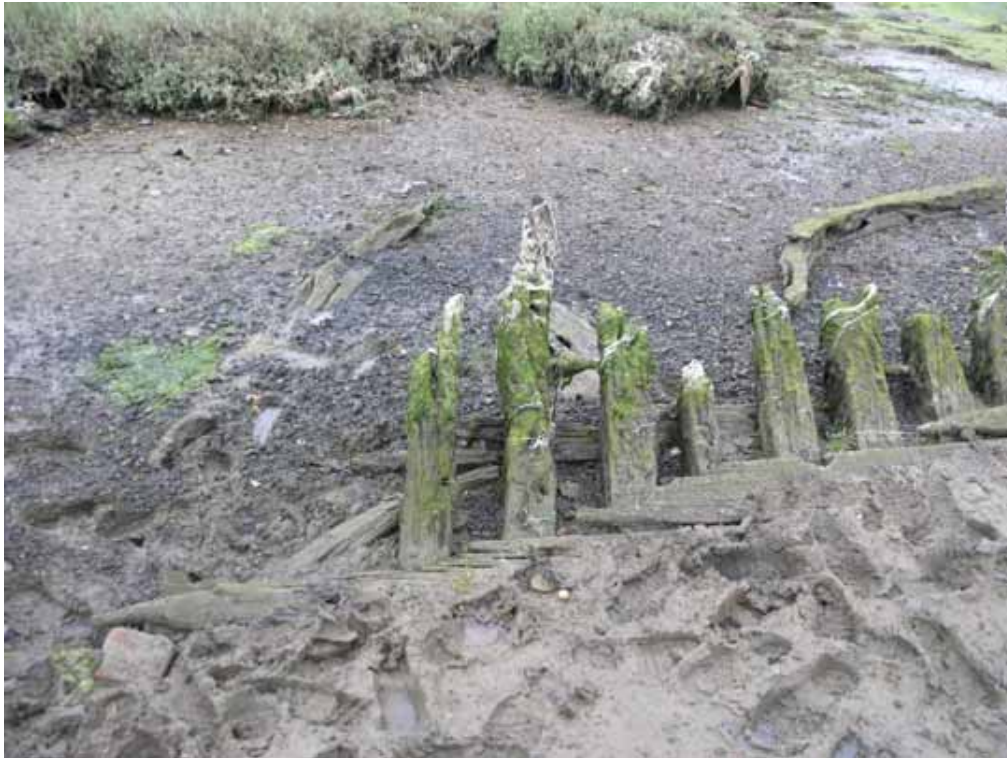
Figure HAM051- 9 Ceiling planking visible just above the silt line, at the starboard forward quarter (looking north)

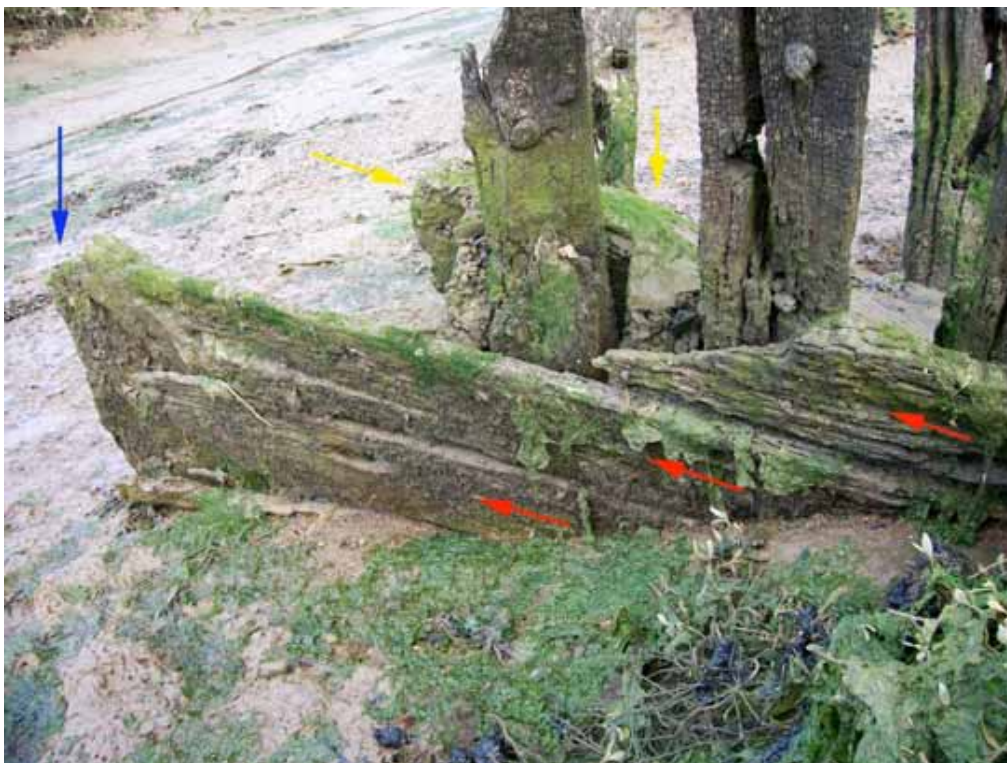
Figure HAM051- 10 The bow section with hull planking (red arrows), the stempost (blue arrow) and the concrete ballast (yellow arrows) indicated (looking north)

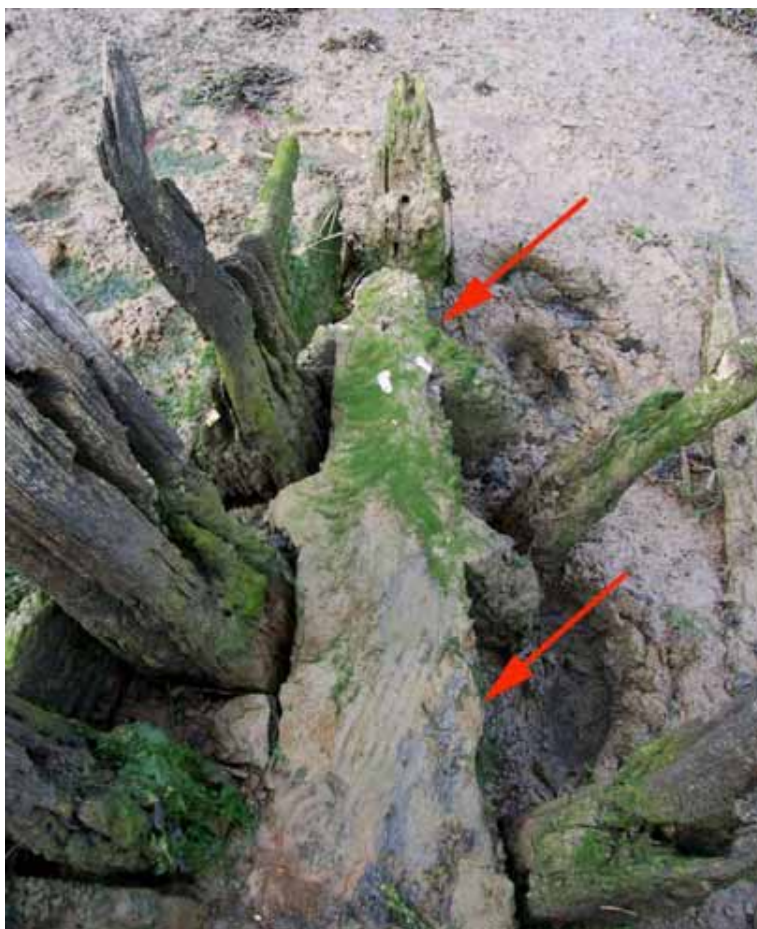
Figure HAM051- 11 An image showing the concrete ballast in the bows

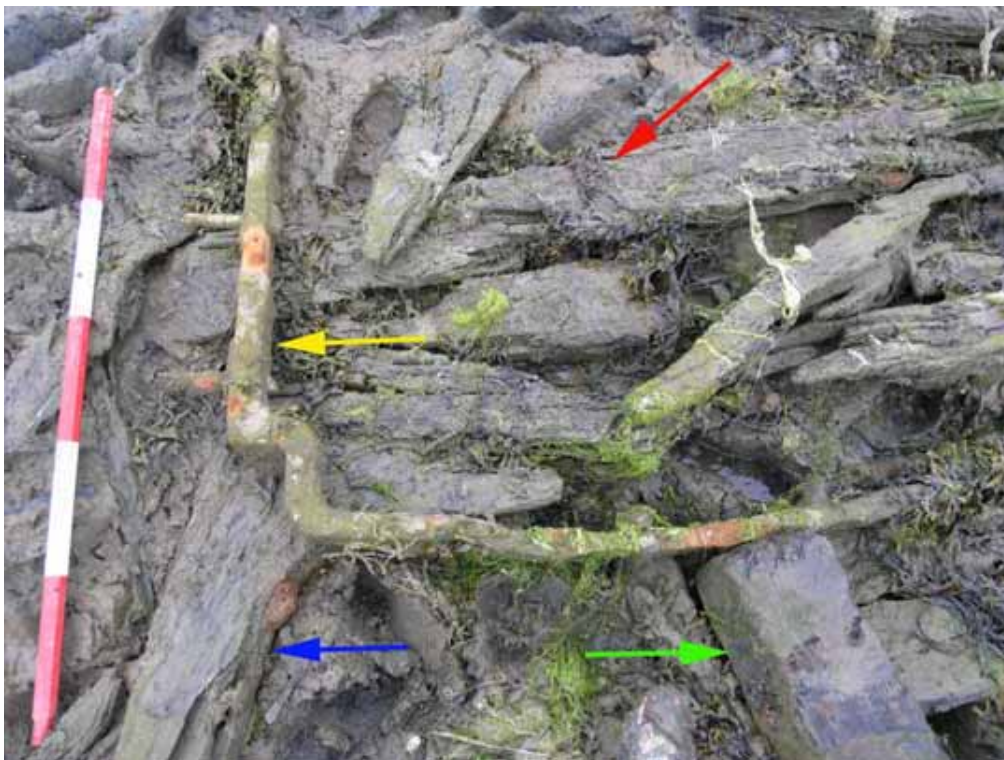
Figure HAM051- 12 In the centre of the vessel there are many disarticulated elements, including; planking (red arrow), wooden knees (blue arrow), deck beams (green arrow) and metal knees (yellow arrow)

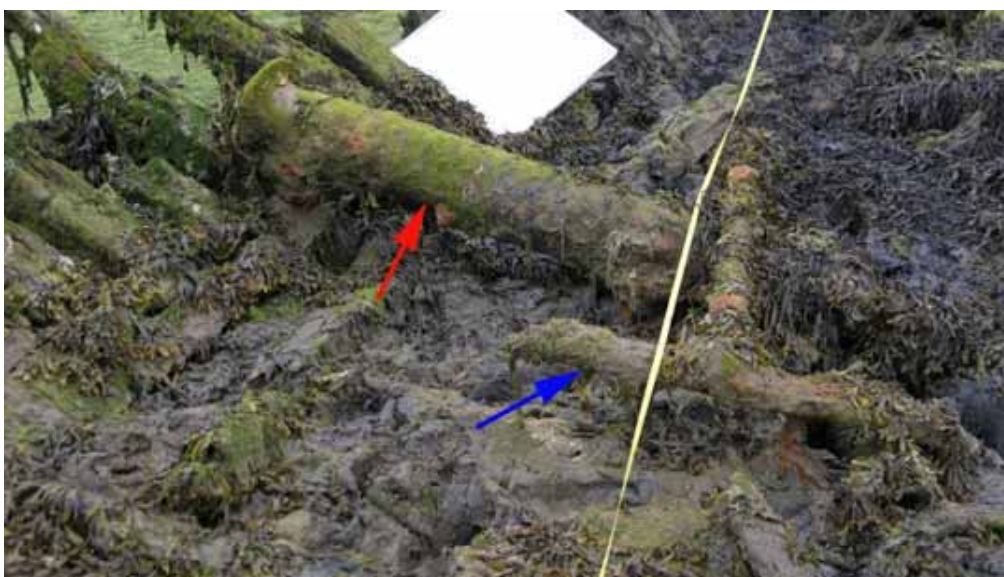
Figure HAM051- 13 Towards the stern there is a large flanged pipe (red arrow) and a collapsed iron stanchion (blue arrow) (looking aft)

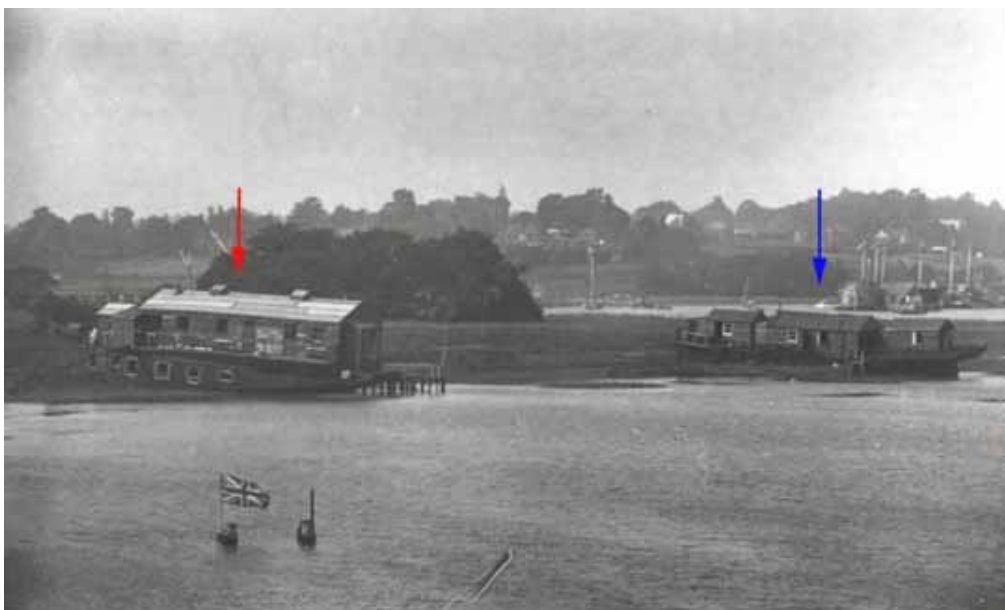
Figure HAM037- 14 The two 'Fever Ships' located near Satchell March. HAM037 (red arrow) HAM051 (blue arrow) (courtesy of Hamble Parish Archive)

During these investigations contact was made with the 'Mercury Old Boys' historian 'Snowy' White. Mr White said that hulks are the remains of two former North Sea fishing vessels *Flash* and *Fortuna*. These were transformed into houseboats and were used as hospital accommodation for the school, and were known by the boys as 'The Fever Ships'. The date that these vessels came to the river is not certain, but they were definitely at their current location by 1913 (Snowy White pers. com. Dec 2007). A photograph of these 'Fever Ships' was found in the Hamble Parish Archives. A copy of this photograph was supplied by Ian Underdown (Figure HAM037-13). The date of this photograph is unknown. It shows the hull of HAM037 and HAM051, and above these hulls timber hut structures have been built. HAM037 appears to be a little larger than HAM051. In the hull of HAM037 at least six windows have been fitted. The pier beside HAM037 can also be seen, although it is short at this time.

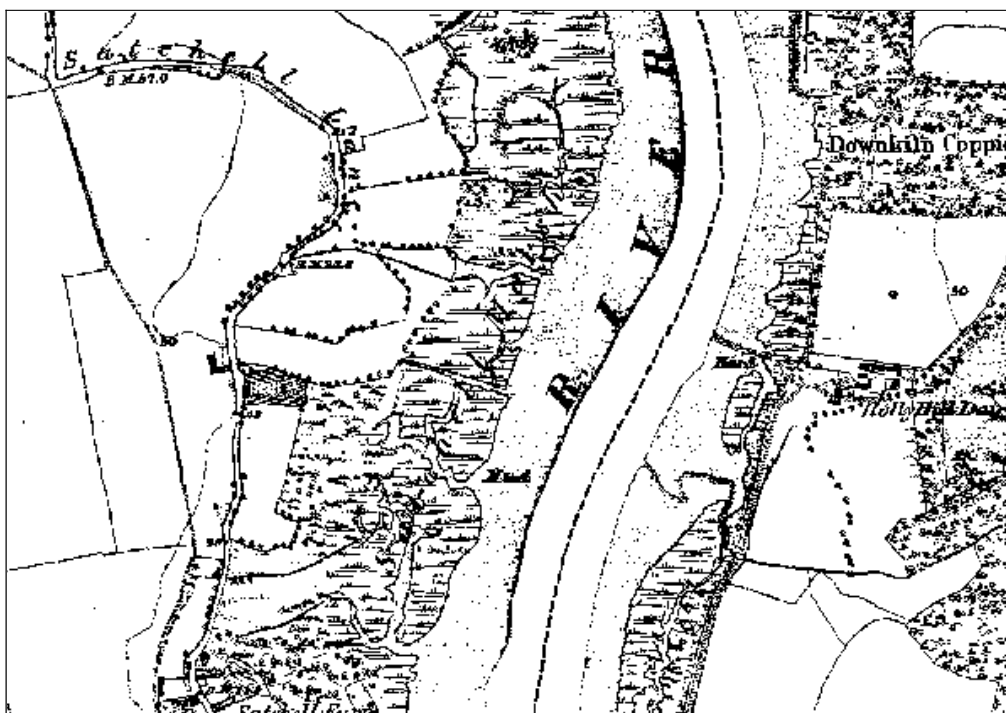
Figure HAM037- 15 The County Series Map of 1870 (Ordnance Survey)

A progression of maps was consulted for indication of these vessels, T.S. *Mercury* or associated features. T.S. *Mercury*, the embankment and the pier do appear on the maps, although the vessels themselves are omitted. The maps researched included the County Series Maps from 1870 to 1989. On the map from 1870 Satchell Marsh can be seen, but there is no sign of the human made embankment of the jetty (Figure HAM037-13).

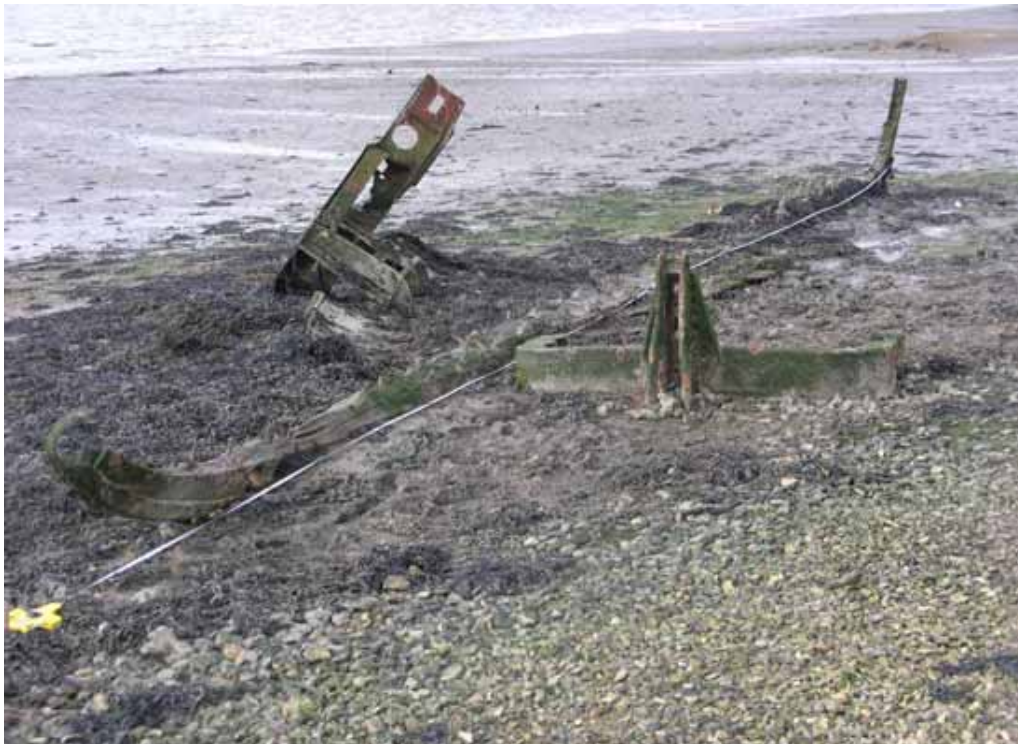
Figure HAM043- 1 The site of an unknown hulk, possibly of a Barnett lifeboat, consisting of a keel, bulkheads and associated structures
