Forgotten Wrecks
of the
First World War

HMS *Boxer*

Site Report

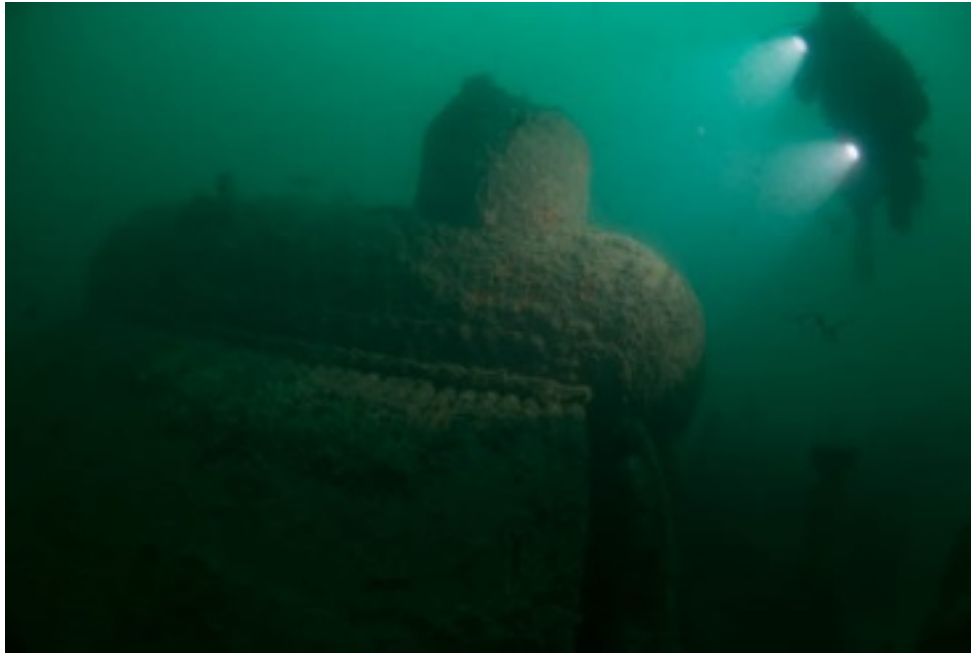
The three Yarrow patent water tube boilers still stand in tandem around 3m apart, and are the highest part of the wreck standing 3.7m high, much of the steel casing around the boilers has long since fallen or rotted away. The water tube boiler is a three-drum boiler which consists of a steam drum at the top with a diameter of 0.9m, and two water drums below. Each boiler is around 2.5m in length with curved steam tubes extending from the steam drum on either side (Figure 6).

Figure 6: Water tube Boiler (photo courtesy Michael Pitts)

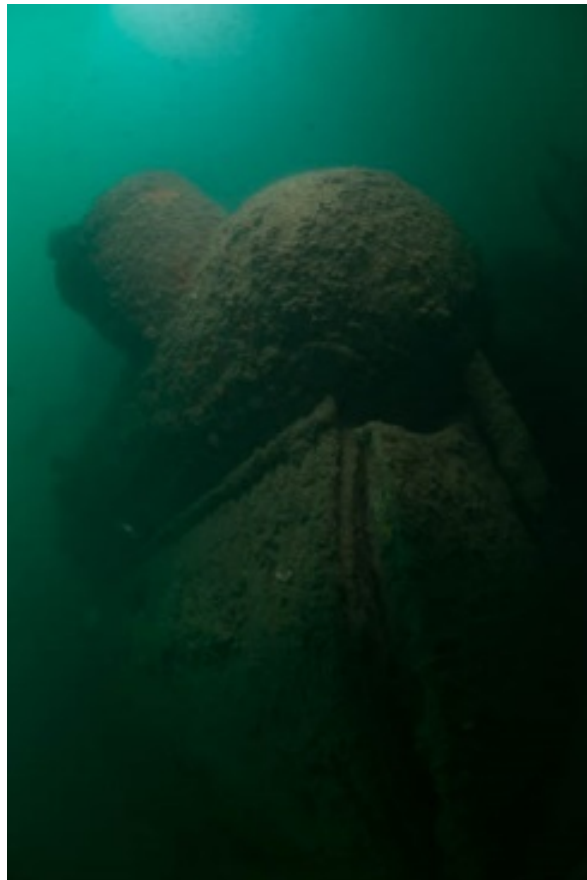
The steam tubes at almost deck level enter a water drum or D shaped 'trough' the length of the boiler, disappearing inside. These troughs lie around 1m away, and parallel to, the remaining standing hull on either side (Figure 9). The hull plate now only stands around 1.2m at the highest point on either side of the boilers, and gradually falls away to nothing forward and astern of the three boilers.

Figure 9: Looking up at boiler from deck level with steam drum and water tubes

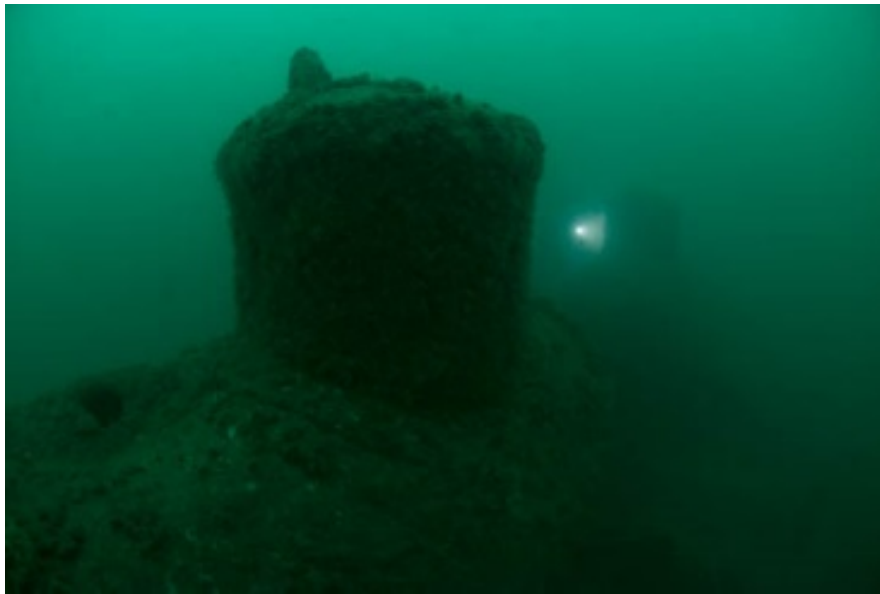
Each boiler has a steam dome or exhaust flue on the top which is 0.5m in height and 0.7m in diameter (Figure 10). At the end face of the boiler are two larger pipes measuring around 0.7m-1m in length with a grate across them measuring 0.6m wide and around 2.7m long (Figure 11).

Figure 10: Steam dome on top of the boiler, a dome on top of a boiler behind can be seen in the distance (photo courtesy of Michael Pitts)

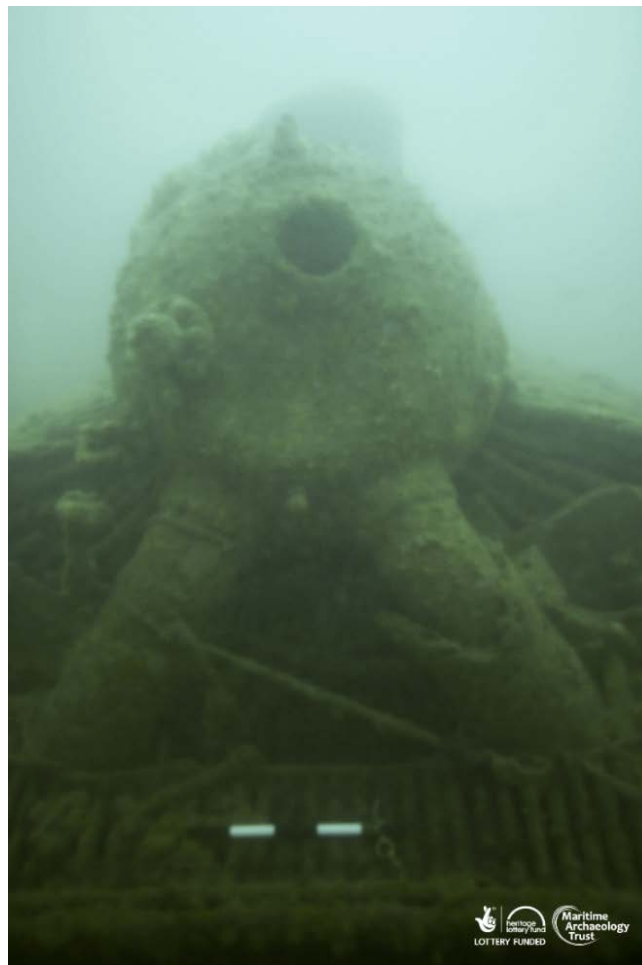
Figure 11: End-on view of boiler

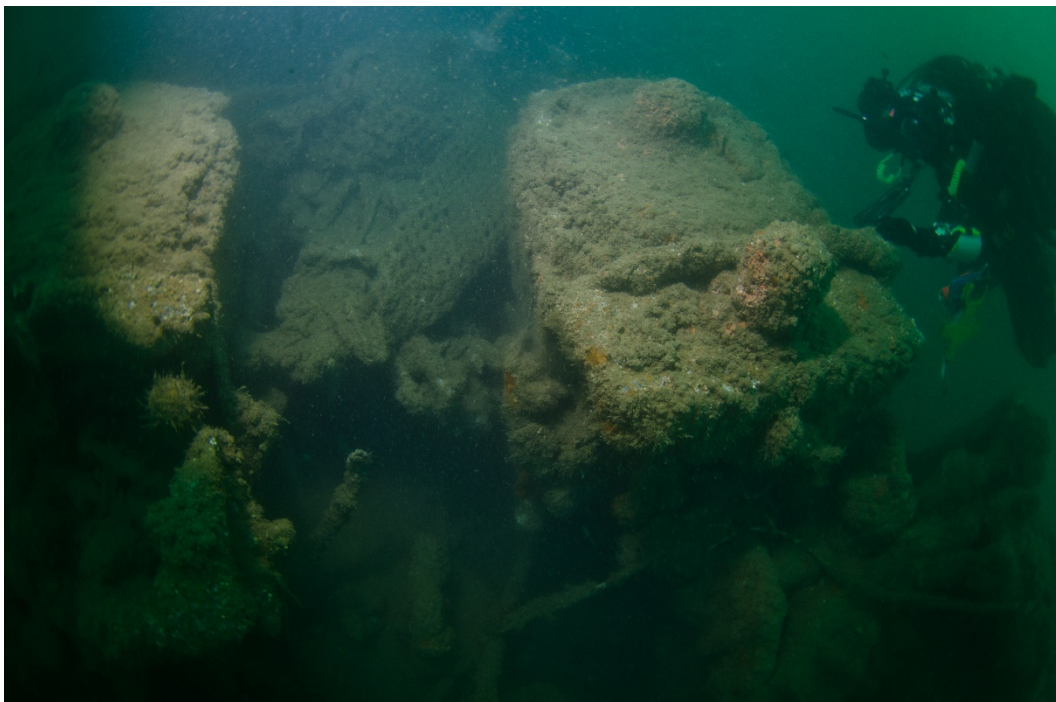
Aft of the three boilers, after a break of around 4m, are the remains of the two, four cylinder triple expansion engines. They are badly damaged as the site is known to have been heavily salvaged, a sketch at Figure 12 gives an artist's impression of what the engines would have looked like. The cylinder diameters of one of the engines measures: low pressure (2 x LP cylinders) 1.2m, medium pressure 0.9m and high pressure 0.5m (Figure 13 and 14). The second engine is very broken making measurements difficult. Metal pipework exists in horizontal and vertical states around the area (Figure 15).

Figure 13: Cylinder heads of triple expansion engines

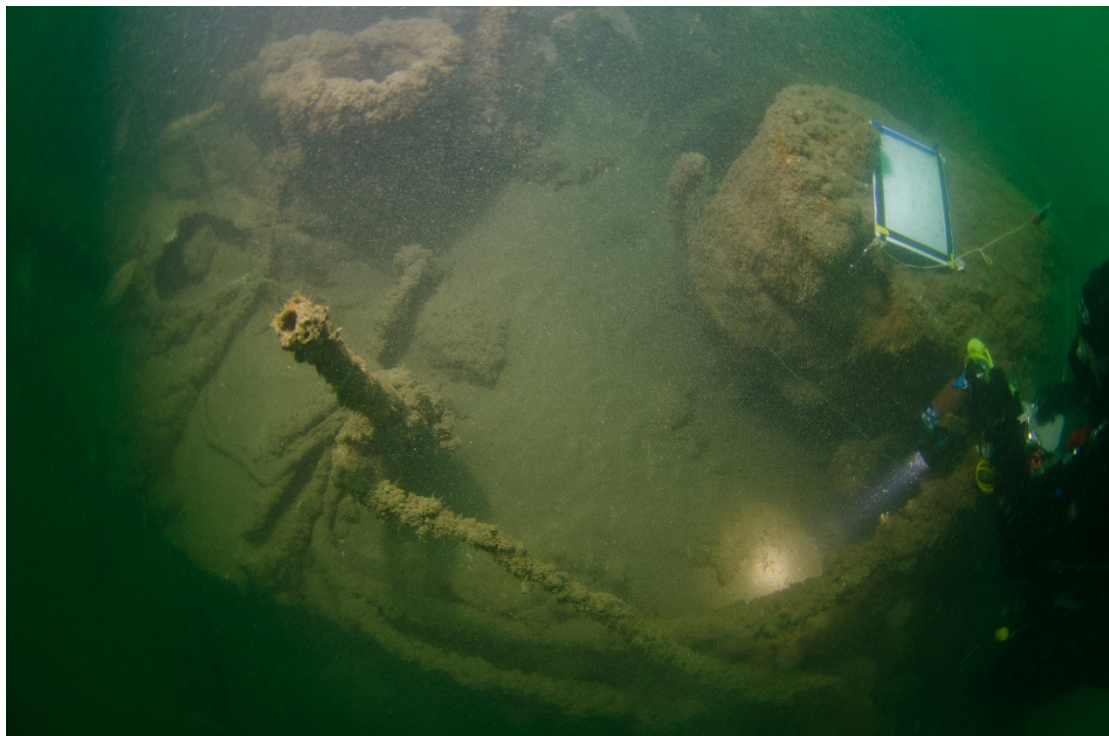
Figure 15: Engine area showing metal pipework

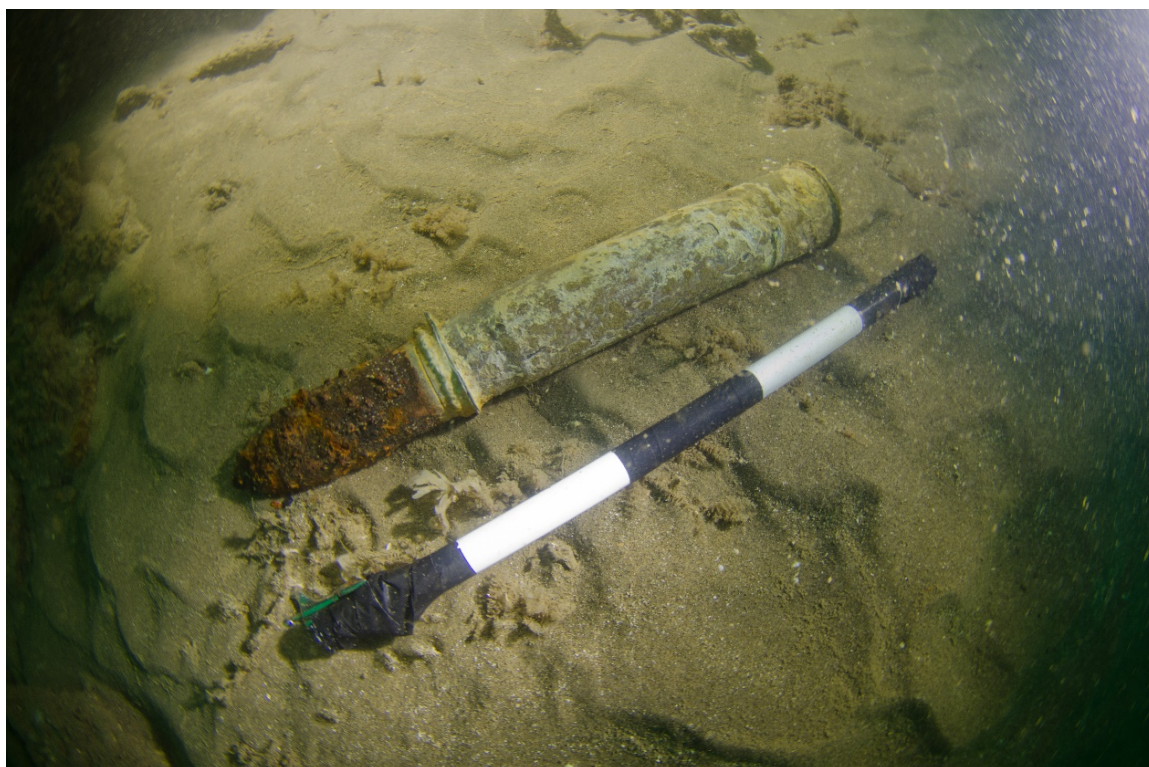
In the area just behind the engines there is a debris field of mixed objects, pieces of coal are evident. Also in this area to the port side of the wreck are two 4" ammunition shells lying near to an ammunition box (Figure 16 and 17) with evidence of wooden boxes scattered just behind these amongst wooden deck planks (Figure 18). Evidence of a bulkhead lies near to the wooden boxes.

Figure 16: 4" ammunition shell

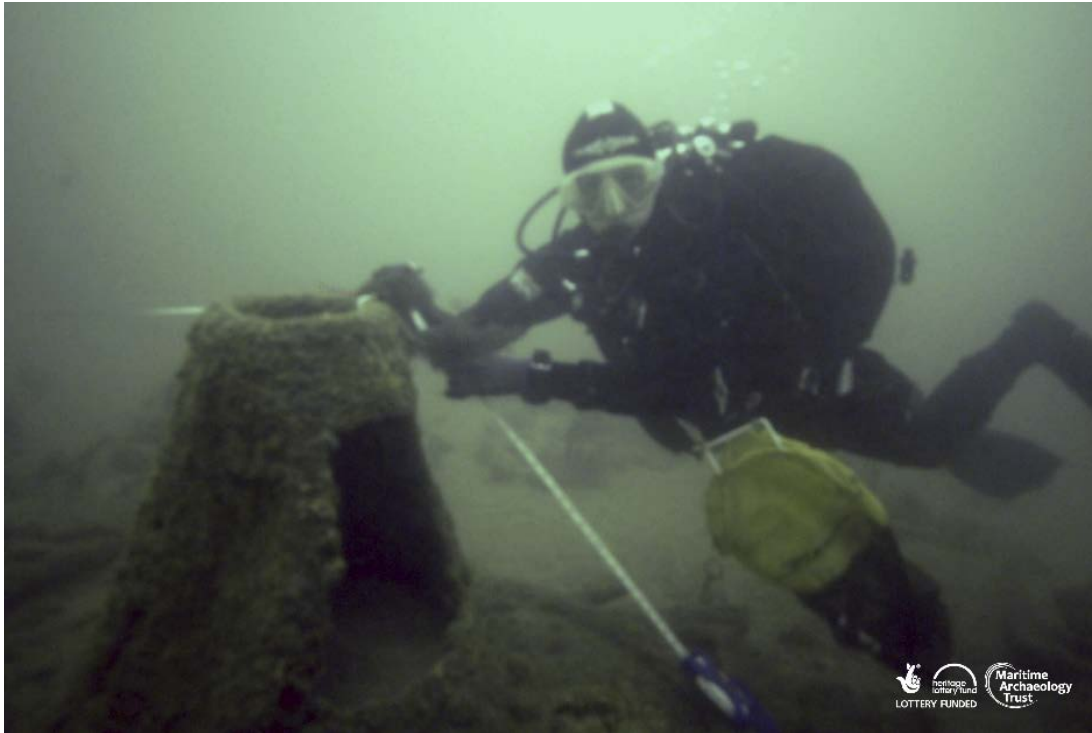
In front of the first boiler, approximately 4m away, is a gun pedestal which measures 0.5m from the bottom to the top of the base, no sign of the gun was recorded (Figure 20). More ammunition shells are found around this area.

Figure 20: Gun pedestal

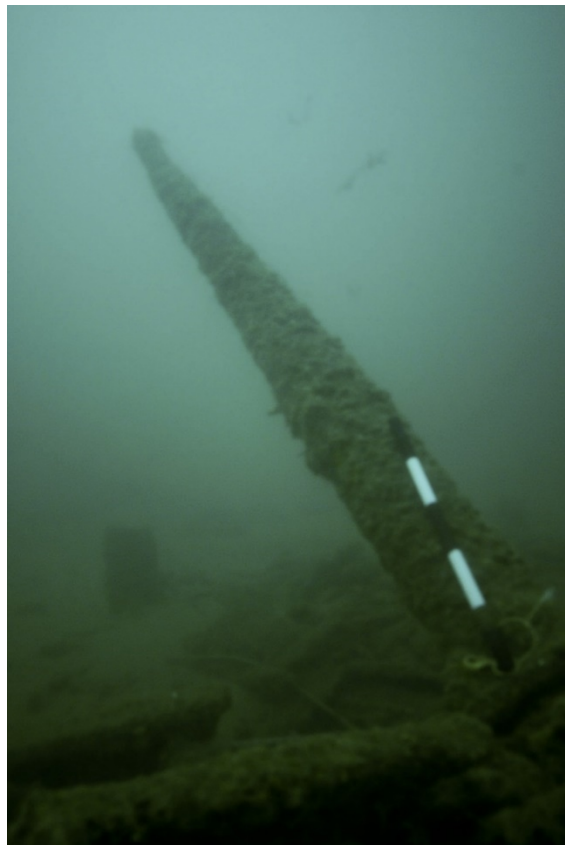
In the bow area, the lower part of the hull survives and gunwales are visible in certain parts. There is the remains of a possible foremast standing approximately 3m high at an angle of 40° to the port side of the wreck (Figure 21).

Figure 21: possible foremast towards the bow area

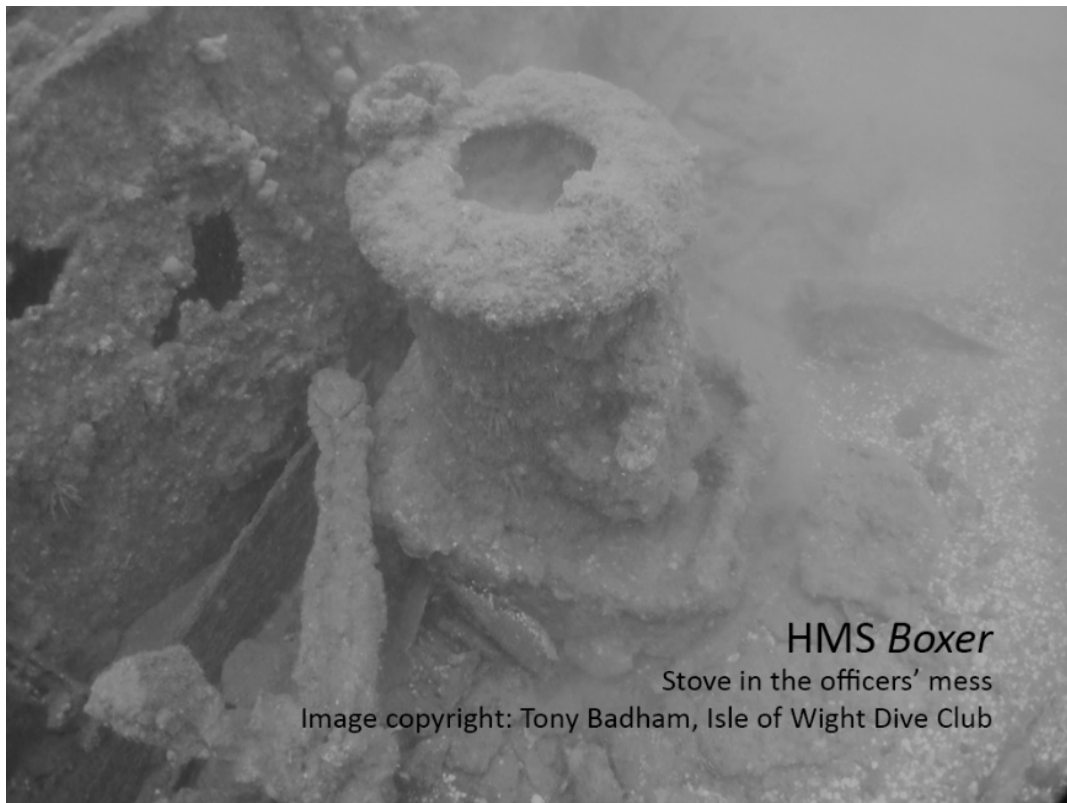
The wreck of the *Boxer* sits within an area of mobile sand, because of this the site appears to change through time as parts of the wreck become covered and uncovered. An interesting image of a stove on the *Boxer* was sent to the Forgotten Wrecks team by Tony Badham of the Isle of Wight Dive club, this has not been located during the Forgotten Wrecks project but can be seen in Figure 22.

Figure 22: Stove on the wreck of the *Boxer* (©Tony Badham)

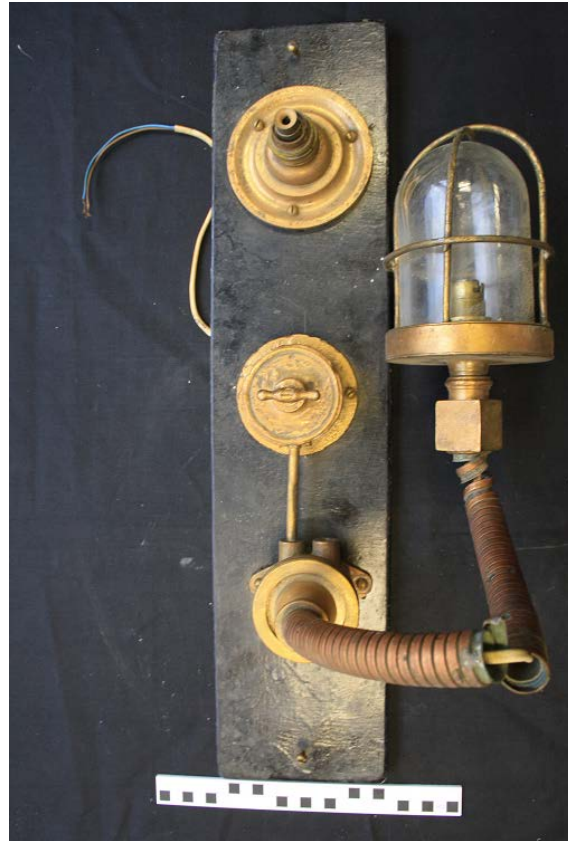
Figure 23: Bronze light set with caged light mounted (artefact ID FW320)

- 4 lamps,
- 2 covers
- 1 electric bell
- 1 brick
- 4 x portholes
- 2 small portholes marked "J Roby Rainhill", size 6.5 inches;
- 1 hatch surround
- 3 x gauges
- 1 x stud
- 1 x coal shute cover
- 1 x hinge
- 1 wooden bed binnacle/compass
- 3 x door tiles
- 1 oval maker's plate marked "Easton, Anderson and Gordon", 7.7 inches
- Letter "O", 5 x 3.5 inches
- 1 engine room bronze wheel marked "Box - Port", 12 inches
- 1 brass indicator marked "stbd - open - shut" 5 x 1 inches
- 1 wood/brass box
- Bronze light set with cage light mounted (Figure 23)
- Steam Siren
- Ships Ensign

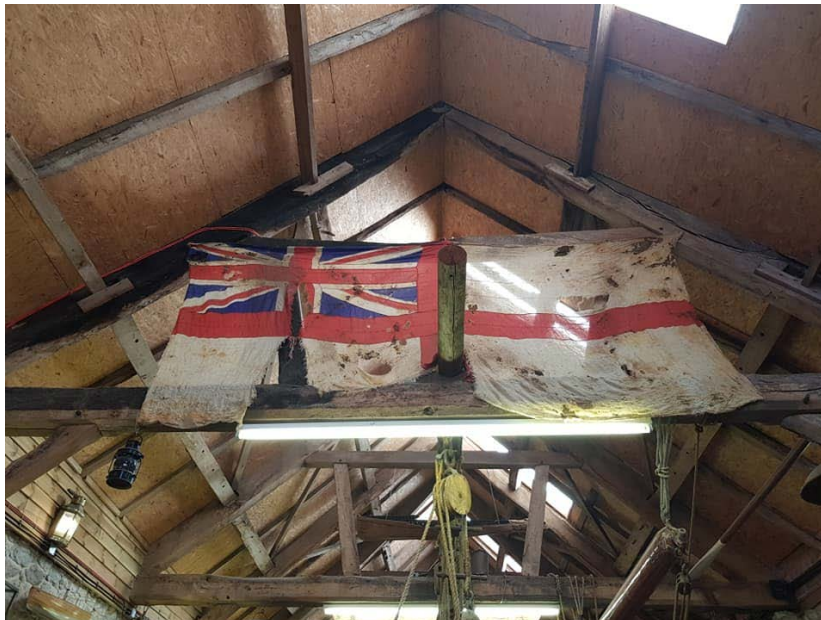
Figure 24: Ensign from HMS Boxer hanging at Shipwreck Centre

In 1999 E.J Towse visited the wreck site located, in a heap of ironwork, the ships ensign still in remarkably good condition (Figure 24). The flag was reported to the Receiver of Wreck and presented to the Isle of Wight Shipwreck Museum in on 15 September 2007, it now hangs in the main exhibition gallery (MCDOA News Archive, 2007).
