**Forgotten Wrecks
of the
First World War**

**May
2018**

***Lord John
Roberts***

Site Report

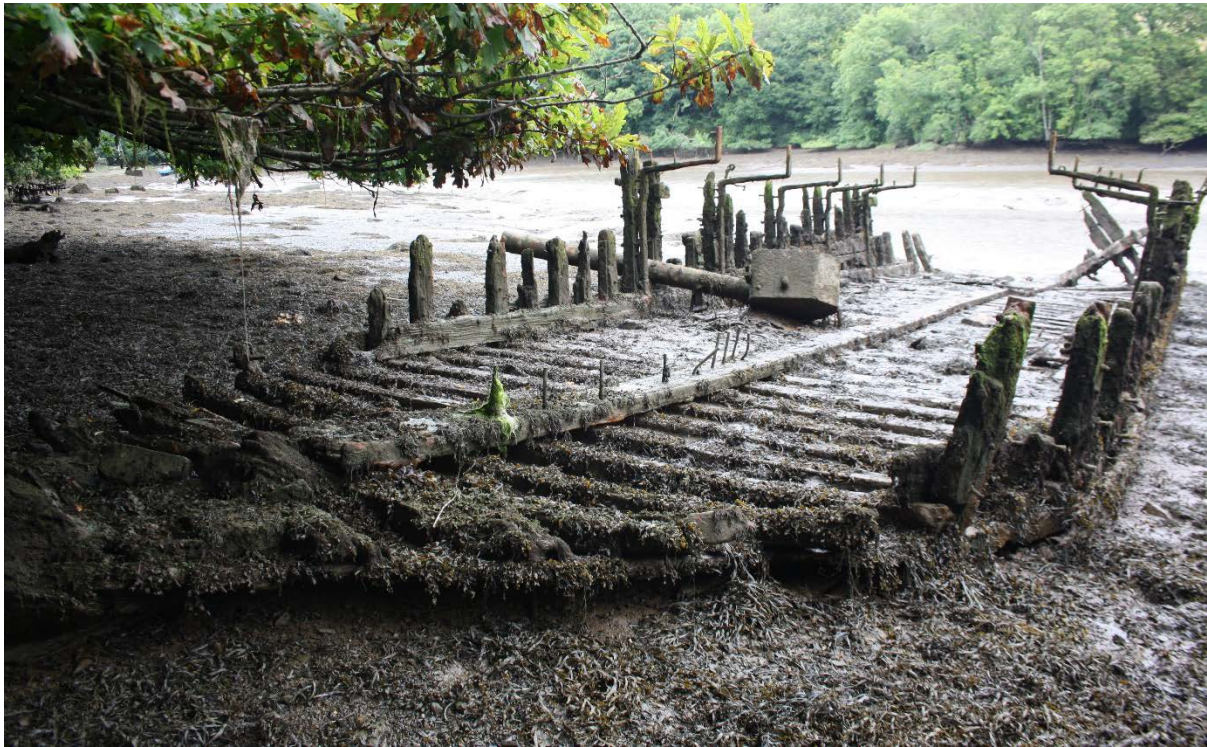
FIGURE 1 – THE SITE THOUGHT TO BE THE LORD JOHN ROBERTS AS VISITED IN 2017

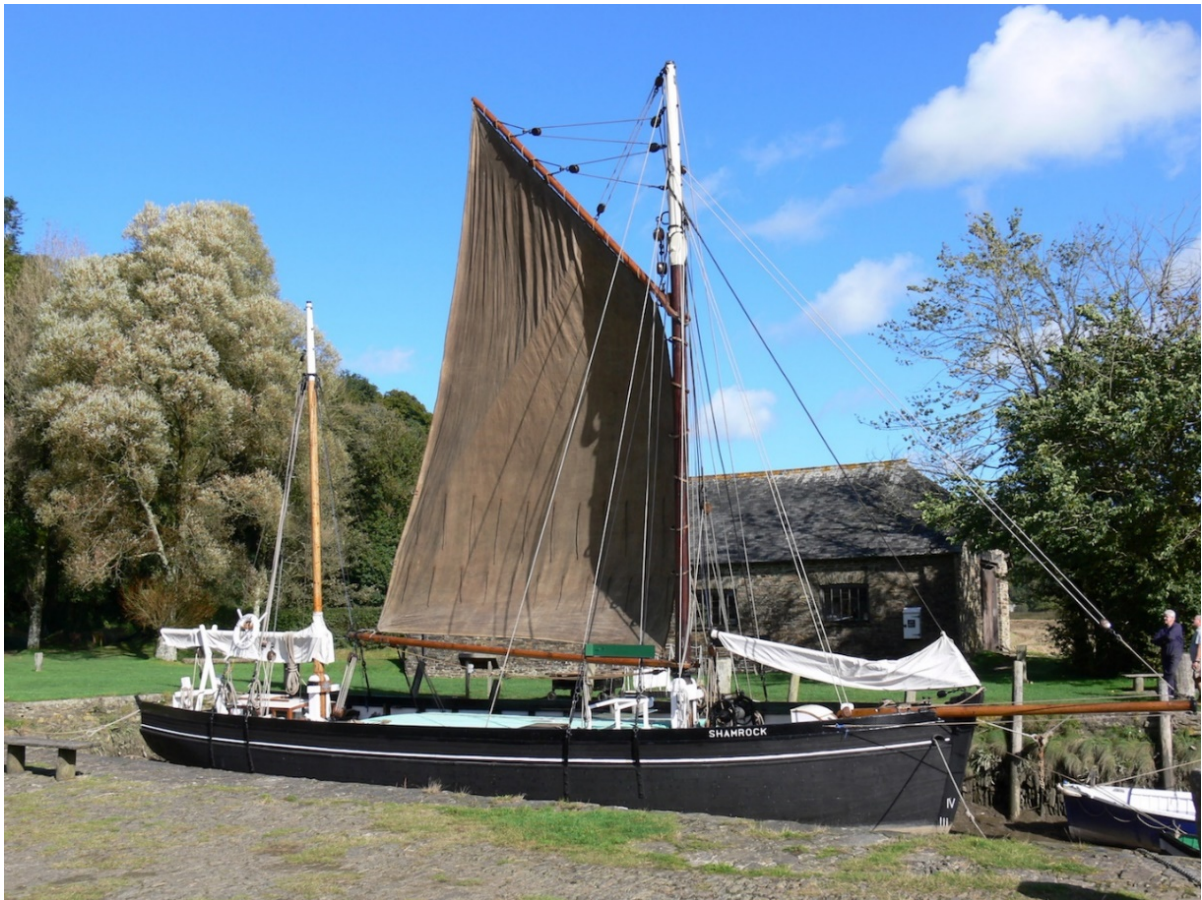
FIGURE 2 - PHOTOGRAPH OF THE TAMAR BARGE SHAMROCK ([HTTP://SHAMROCK-COTEHELE.BLOGSPOT.CO.UK/P/ALL-ABOUT-SHAMROCK.HTML](http://shamrock-cotehele.blogspot.co.uk/p/all-about-shamrock.html))

Two Tamar barges *Shamrock* (Figure 2) and *Lynher* were restored in the 1950-60's. *Lynher* is an example of an Inside barge while *Shamrock* represents the larger Outside barges and is more comparable to the vessel remains being surveyed.

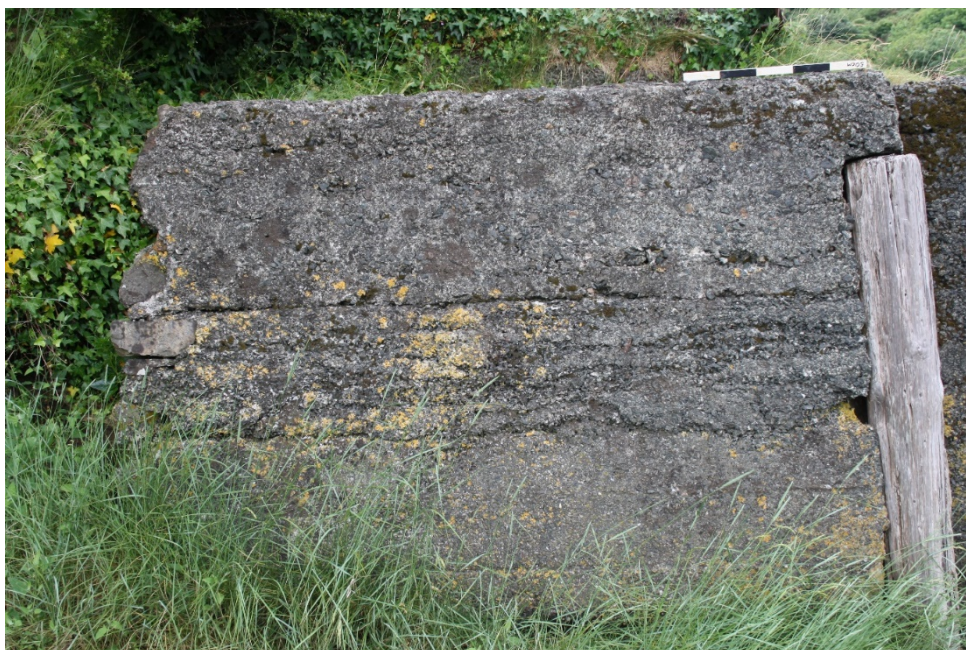
FIGURE 4 - REMAINS OF STONE QUAY

The town of Saltash and Forder Creek itself had a well-established stone trade which was thriving until the middle of the 19th Century. There were a few small quarries worked for building stones, the quay

pictured in Figure 4 (Remains of stone quay) is believed to be connected to this trade, an interpretation which was confirmed by a local resident during survey work.

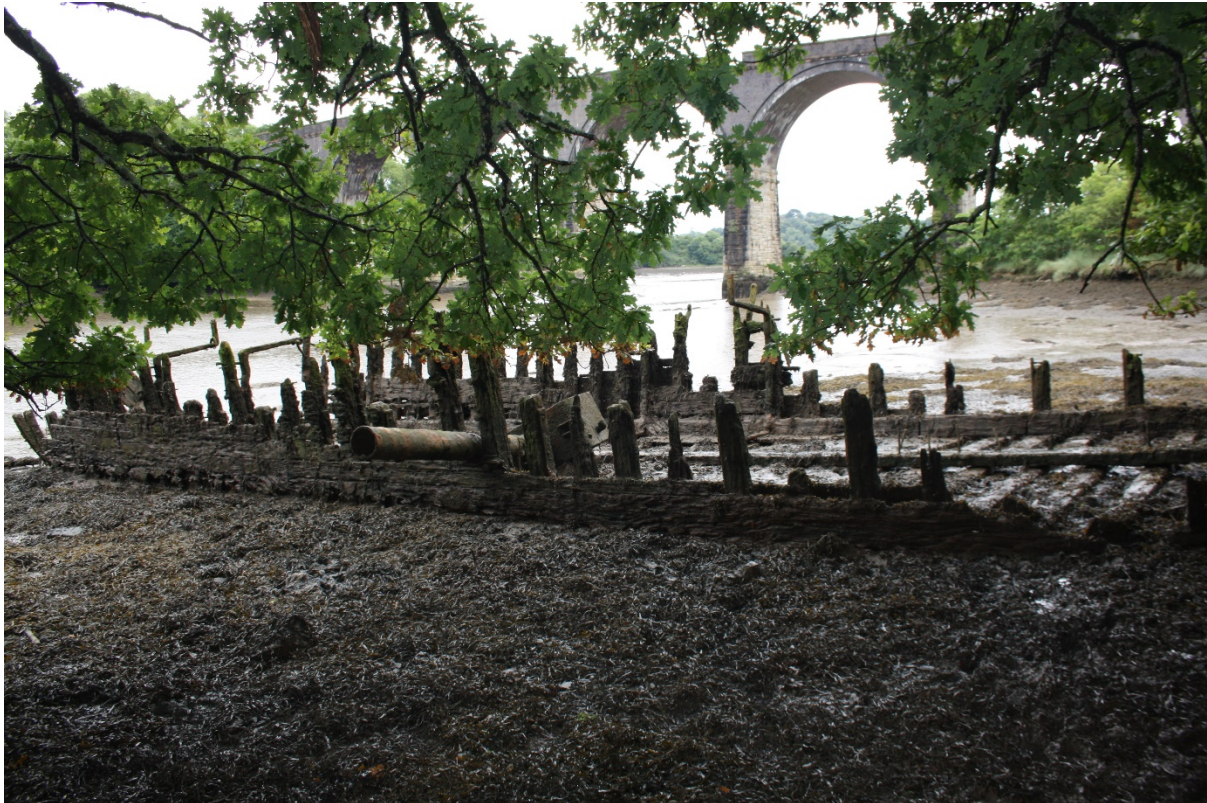
FIGURE 5- SITE OF THE LORD JOHN ROBERTS WITH VIADUCT IN THE BACK GROUND

The vessel is orientated bow to the shore with the transom lying in deep, fine sediment toward the centre of the channel (Figure 5). Because of its location high up on the banks a long tidal window is available to undertake survey allowing up to 4 hours on site. The site can be easily accessed and is visible at high as well as low tide. The stern of the vessel is covered during each tidal cycle and a low spring tide was used to fully survey the site.

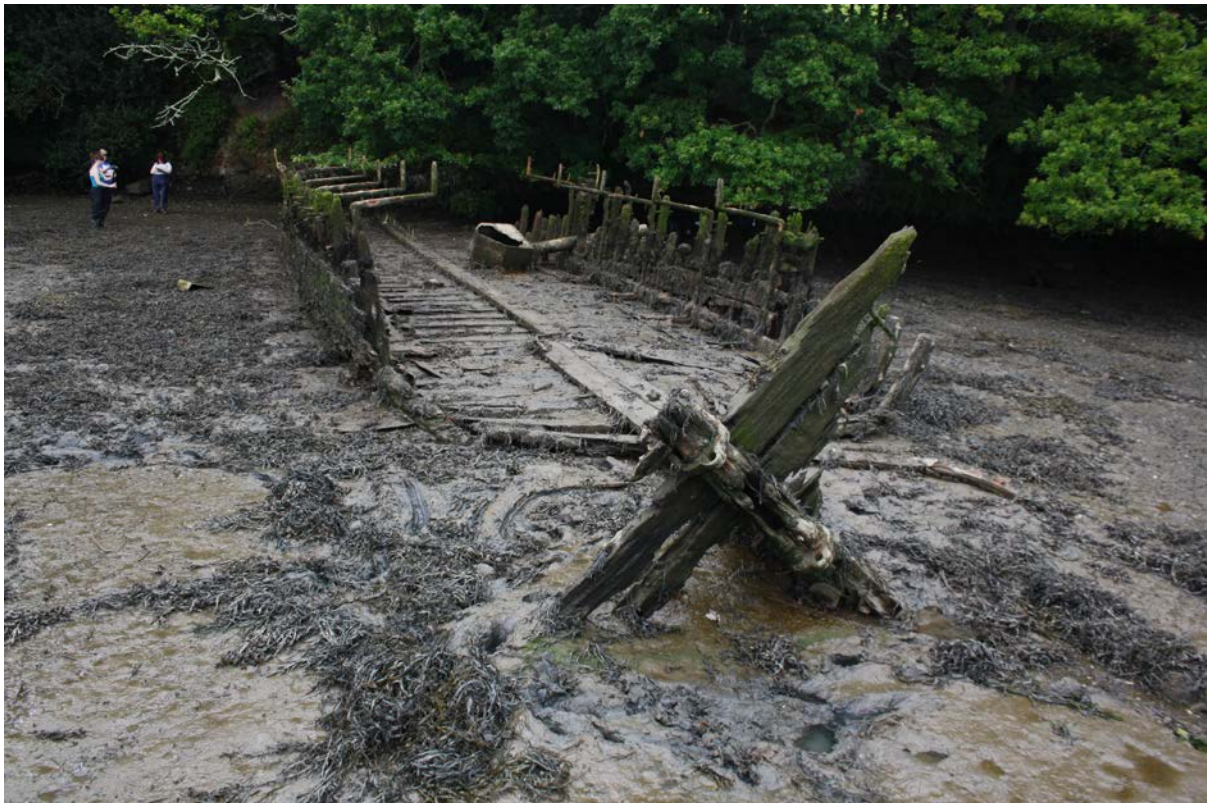
FIGURE 6 - SITE BELIEVED TO BE THE LORD JOHN ROBERTS (WEST FACING)

The vessel is orientated East - West with the bow towards the shore. The remains of this flat bottomed barge measure 21.6m from stem to stern with amidships beam of 5.15m. The vessel is intact amidships from the base of the bilge up to the gunwhale. The transom has become largely detached and is now held at a single point where it is scarfed to the keel and keelson.

The full freeboard of the vessel is shown by the iron knees on top of which the deck would have situated. The five pairs of iron knees also show the positioning and size of the main central hold combing.

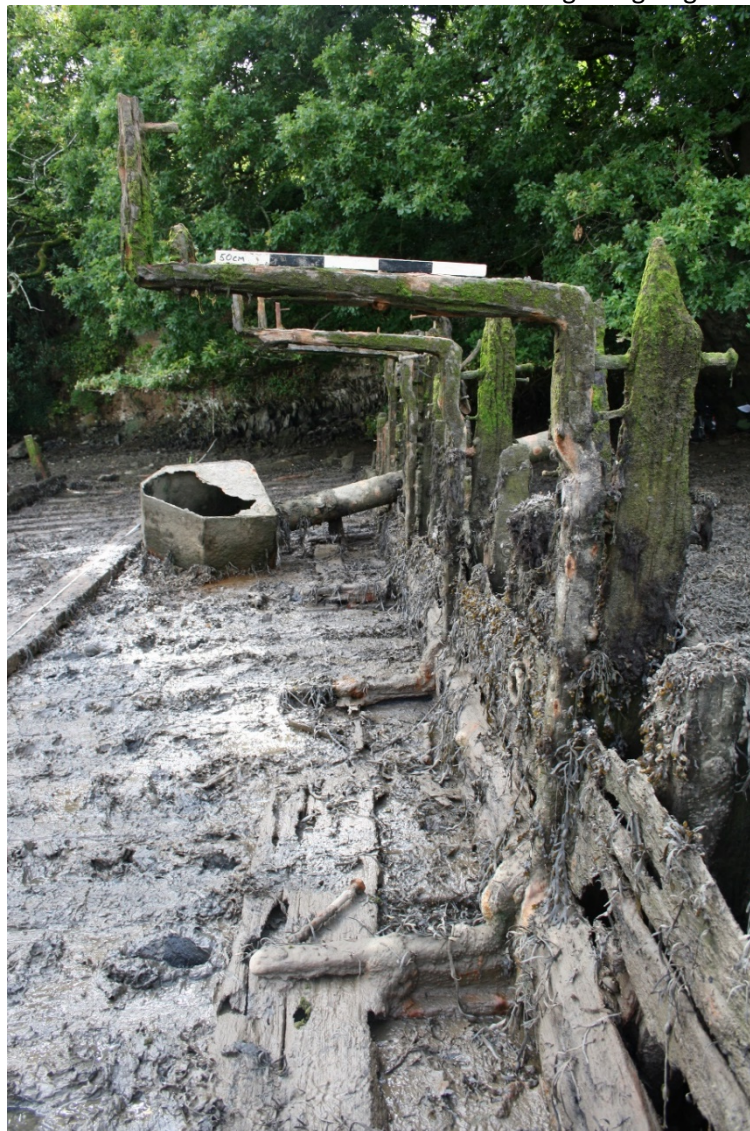
The knees show the height of the main deck, the knees extend down across the bilge as riders giving strength to the transition between the vertical sides of the hull and the flat bottom (Figure 7). The knees have been fitted around the bilge riders and also show evidence of an internal stringer which supported the deck. The iron knees have been fixed to the framing using large iron fasteners.

FIGURE 7 - IRON KNEE AND BILGE RIDERS

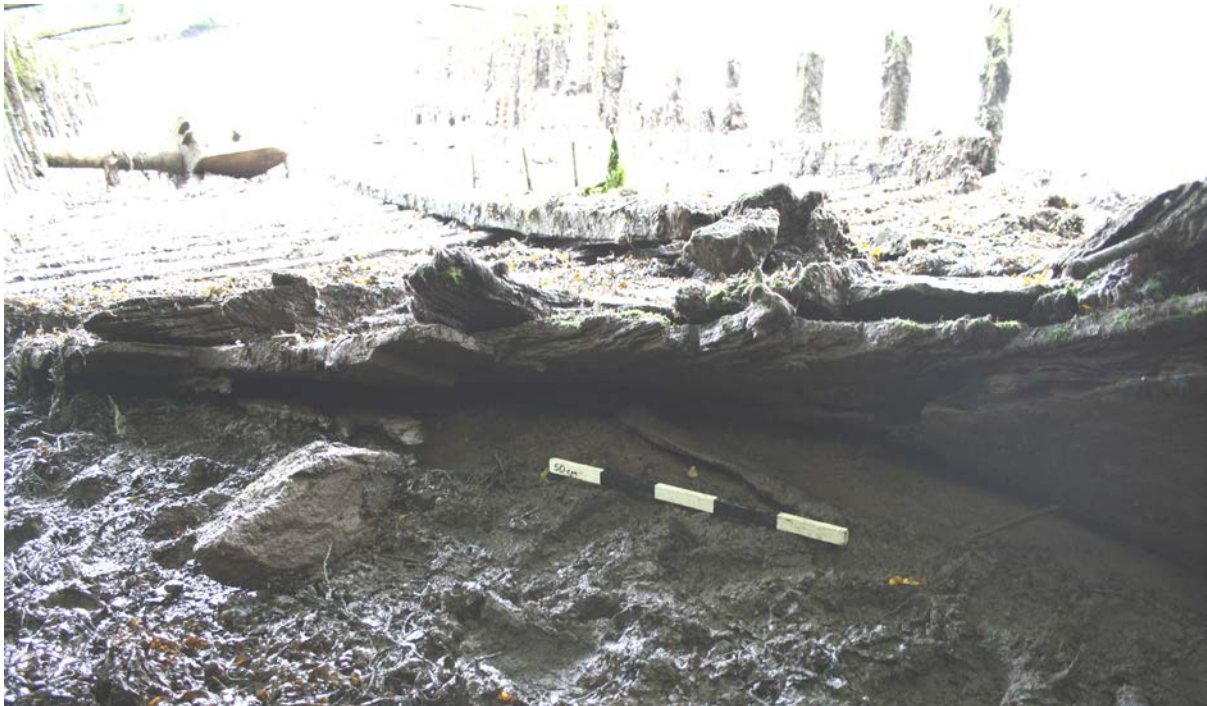
FIGURE 8 - SCARFS OF PLANKING, SECOND LAYER OF PLANKING

The planking is attached with a series of flat scarves shows in Figure 8, that also shows remains of metal on the far right and the secondary layer of planking. The strakes of the siding are currently well preserved, however, they are eroding out rapidly. Only three or four are present on each side which, compared to the condition seen in recent years, is a rapid loss. Three sets of matching eyebolts are present, these relate to the chain plate and rigging in general. Two of the matching pairs are eyebolts of a similar form, the most forward placing set of eyebolts are different in form to the others.

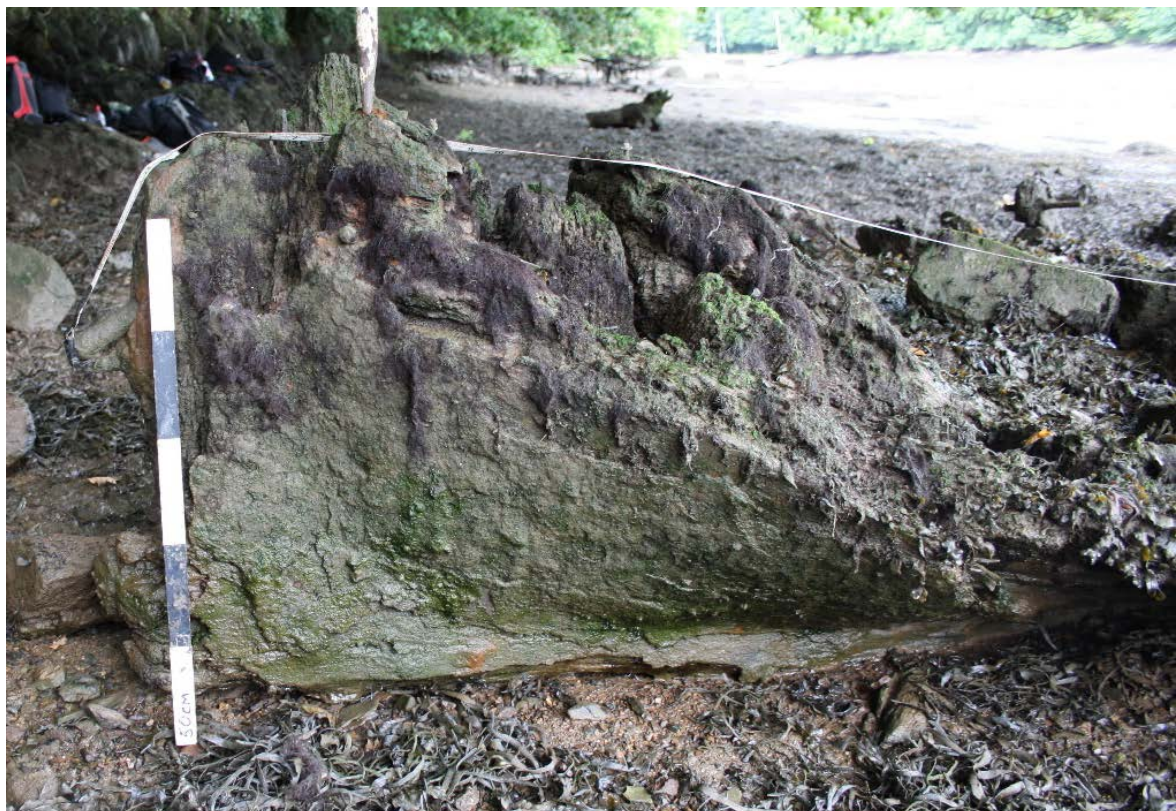
FIGURE 9 - CLOSE UP OF THE BOW ON THE PORT SIDE

The vessel has a shallow keel which is mostly buried and is clearly flat bottomed, the lower hull has been reinforced with a secondary layer of planking and then the keel and hull sheathed with an unknown metal, which clearly has some iron content judging from the corrosion present.

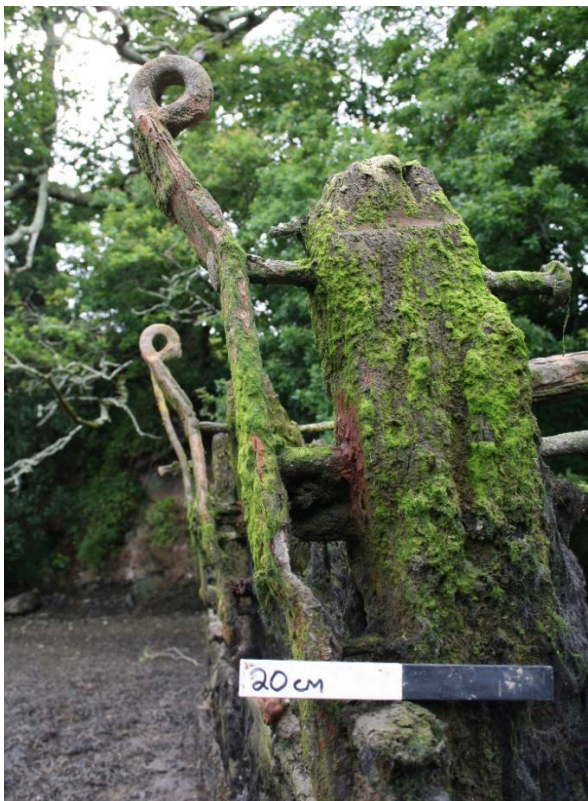
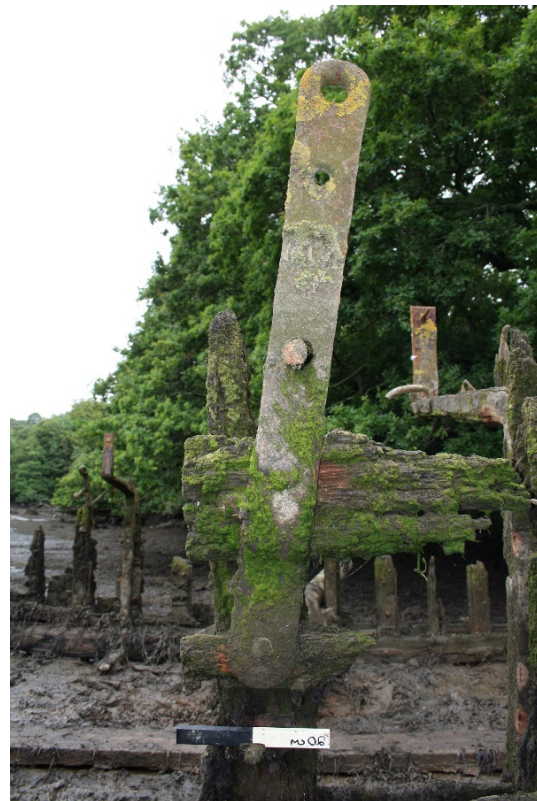
Towards the stern the two pairs of eyebolts are fixed into the framing. These are presumed to correspond with the position of the mast and deadeyes (see Figure 10). The eyebolt strapping has been bent around to accommodate the gunwhale (also shown in Figure 10).

FIGURE 10 (LEFT) - STERN RETAINING EYEBOLTS; FIGURE 11 (RIGHT)- RETAINING RING

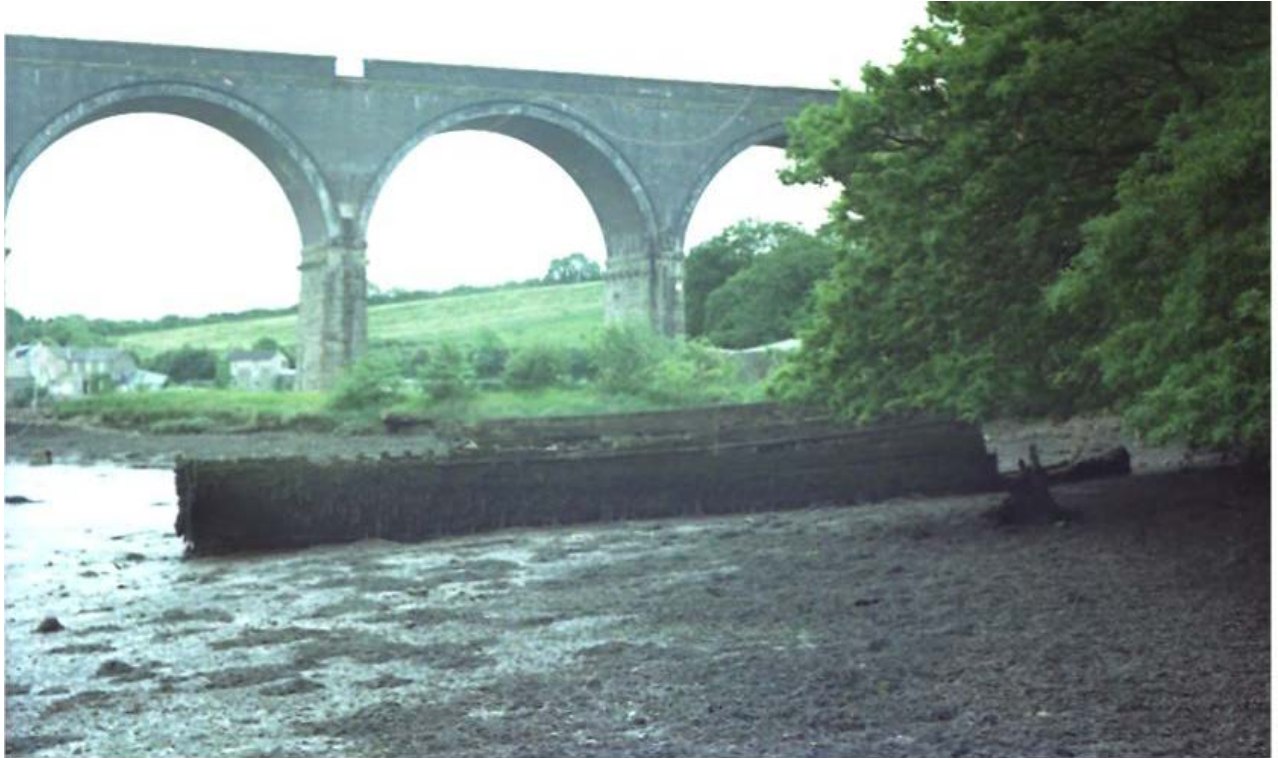
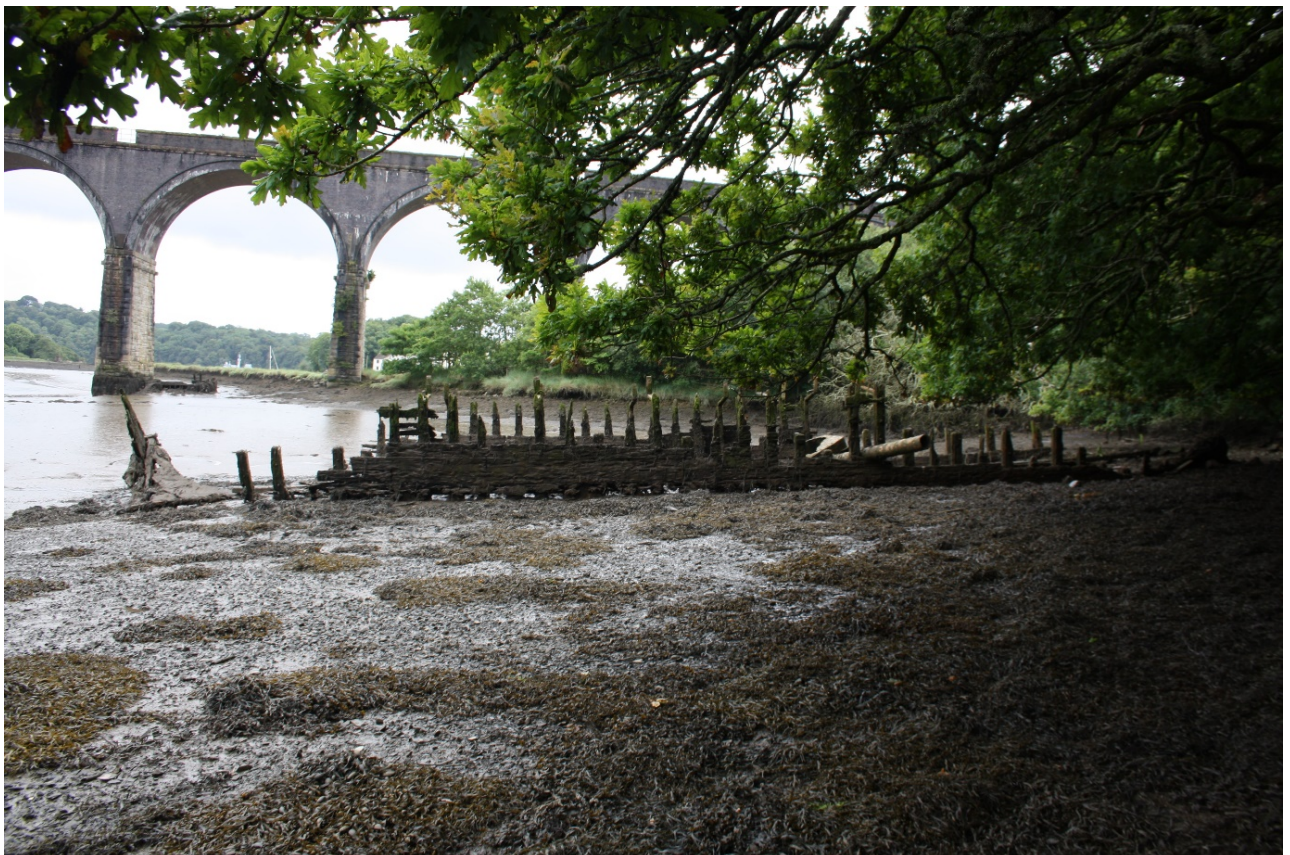
FIGURE 12 - THE SITE IN 1982 (PLYMOUTH HULKS THE FORGOTTEN SHIPS AROUND PLYMOUTH, 2011) CC JOHN COTTON

FIGURE 13- FWFWW THE SITE IN 2017 (27/07/17)

Comparison between the 1982 image (Figure 12) and those from 2017 (Figure 13) demonstrates the relatively rapid rate of degradation at the site. The site is not stable with further areas deteriorating and becoming dislodged. The planking strakes are quickly eroding and rotting with only three of four now present on each side of the hull.

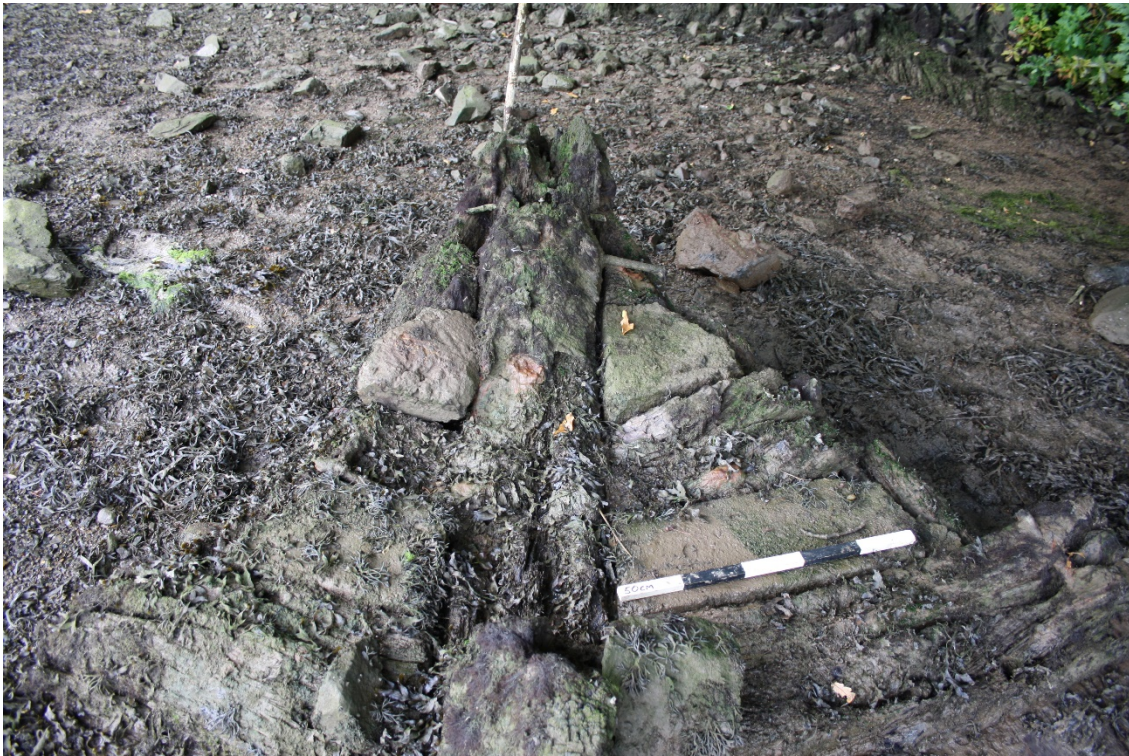
In the bow concrete has been poured internally between framing, it is not known when this was added, but is a relatively common occurrence with wooden hulks as they get older. As the blocks of concrete are large it might suggest it was for weight as well as to help to prolong the life of the vessel. The blocks are 0.27m across and likely 0.14m in depth. The concrete is a fine concrete and can be seen in Figure 14.

FIGURE 14 - CONCRETE INTERESTED BETWEEN FRAMES IN THE BOW

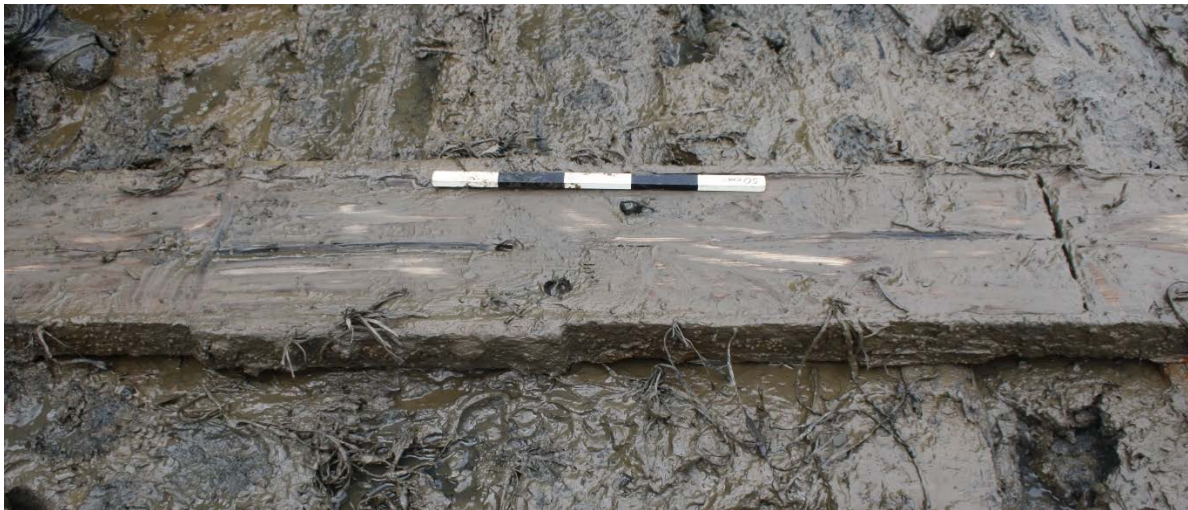
The keelson has two visible rebates cut into it (See Figures 15 and 16), situated just forward of the main hold hatch. The larger of the two (Figure 15) is made up of two filler pieces used to plug what is a potential mast step, perhaps suggesting conversion or refit. The filler pieces are 1.20m in length and extend across the full width delineated by additional metal banding that reinforces the support for this feature. The other rebate is further forward and considerably smaller 0.3m x 0.15m in width with a depth that does not exceed 0.05m. The purpose of this rebate is unknown, it may be a crutch.

FIGURE 15- FWFWW - 2017 - CENTRAL REBATE WITH FILLER PIECES

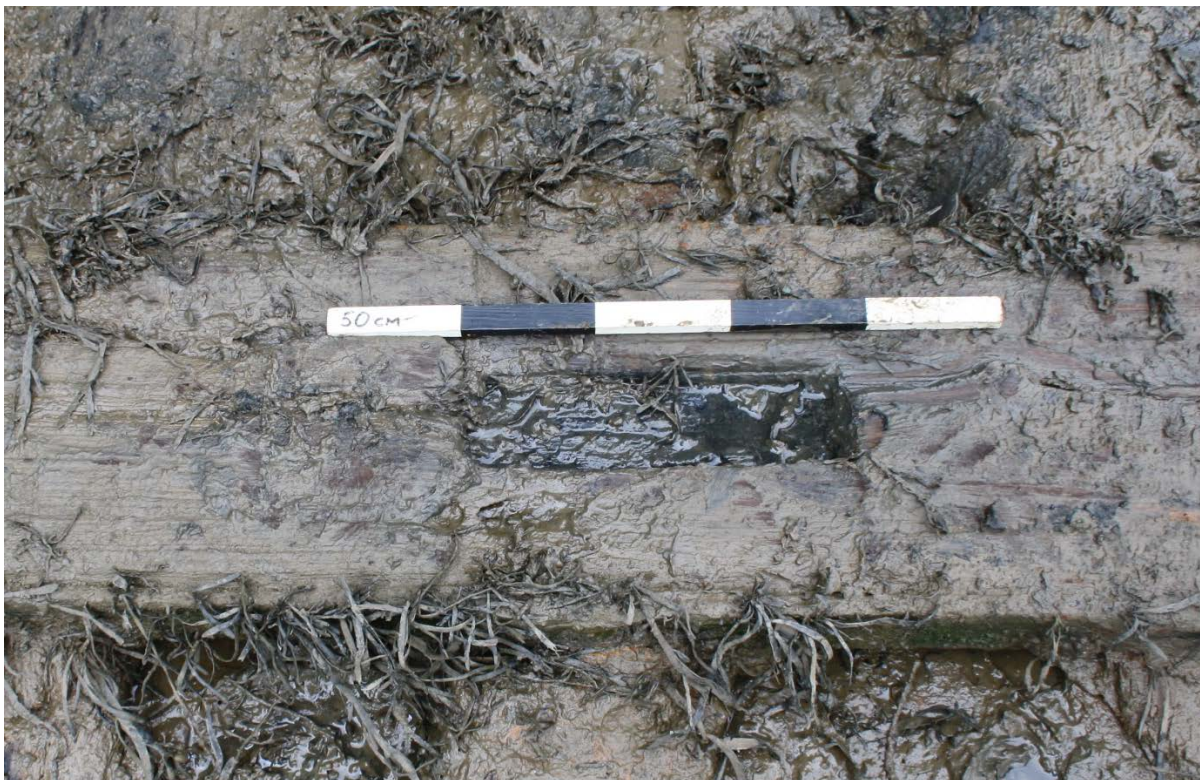
FIGURE 16 - SMALLER REBATE TOWARD BOW

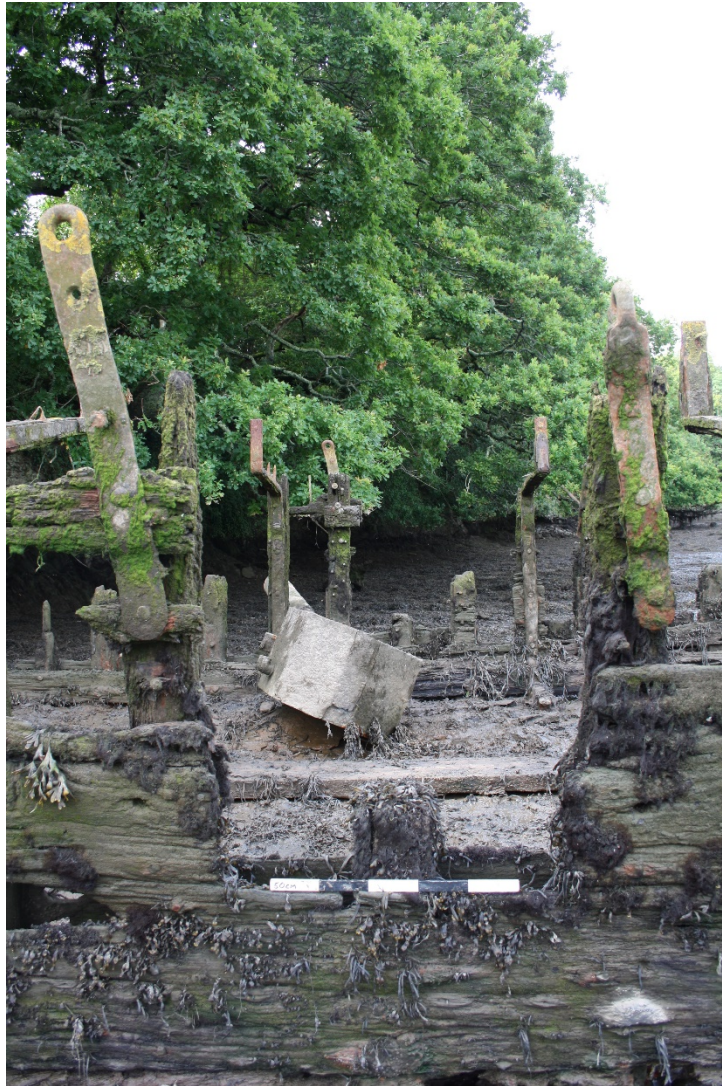
In the port side there is a large cut in the hull interpreted as a gangway with a potential similar cut of the same dimensions on the opposite side. The cuts are 70cm wide and cut through the original framing (see Figure 17).

FIGURE 17 - FWFWW 2017 - POTENTIAL GANGWAY.

The site shows evidence of changes to the vessel undertaken during its working life. The two entrances or gangways that have been cut into the hull towards the bow of the vessel are likely to have been for access, however, they would have made it very impractical when in use carrying cargo. These gangways could have been added when the vessel was used as a Scout hut.

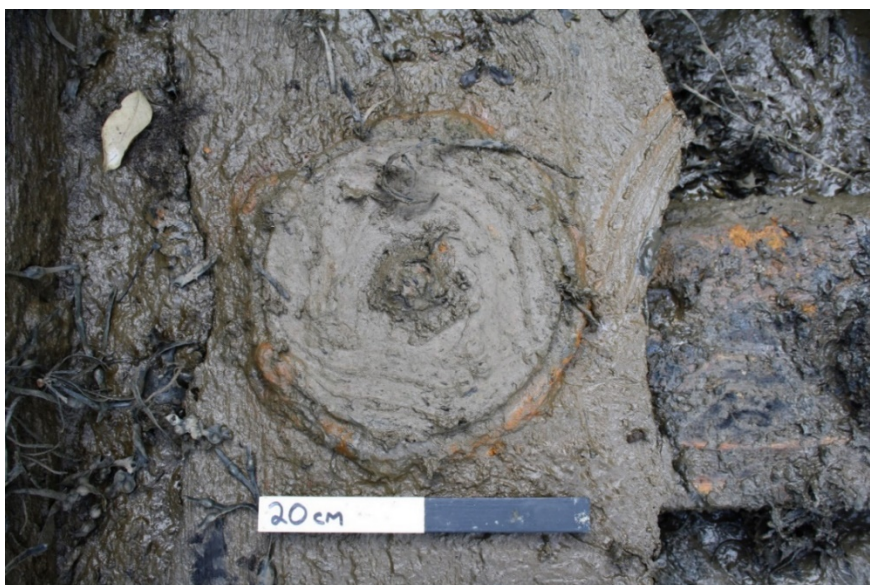
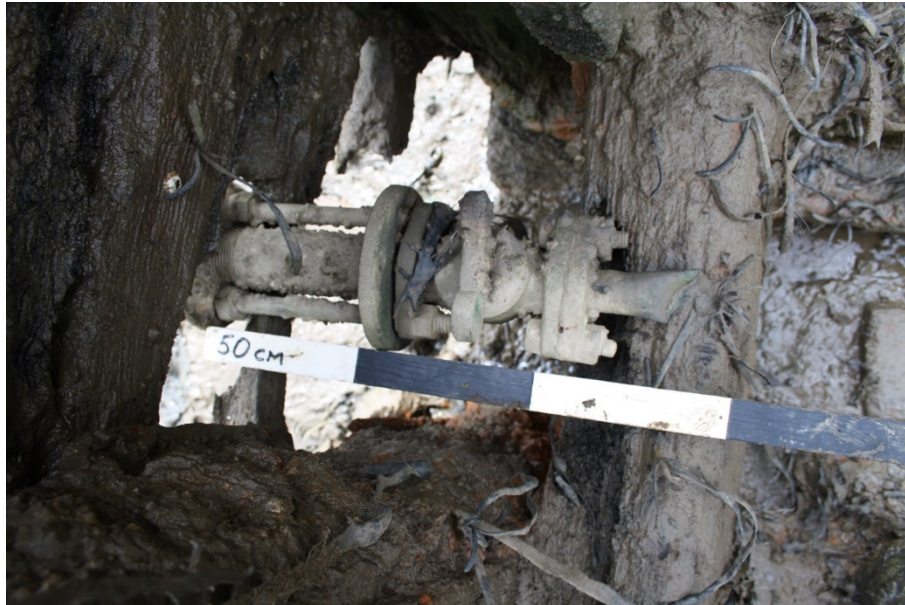
Internally there are a number of fixtures and fittings relating to the pump, securing cargo and of an unknown purpose. The pump fittings are still extant, with some present protruding outside of the hull (Figure 20), they suggest it would have been a machine driven pump. The housing of the pump mechanism would appear to have been located against the siding close to the seacocks on either side of the vessel (see Figure 18 and 19).

FIGURE 18 - TRACE OF PUMP HOUSING

FIGURE 19 – INTERNAL SEA COCK / PUMP FITTING

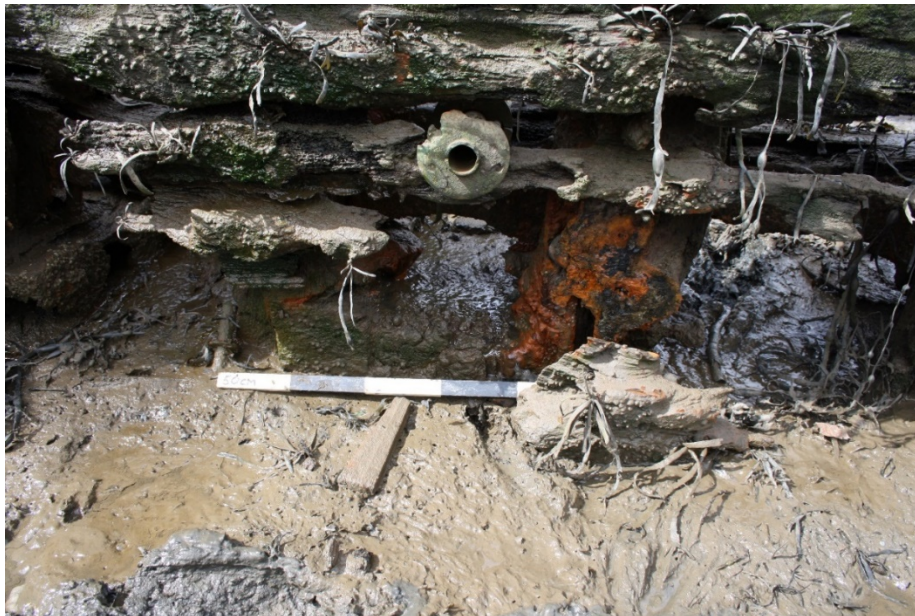
FIGURE 20 - EXTERNAL SCUPPER/ OUTLET

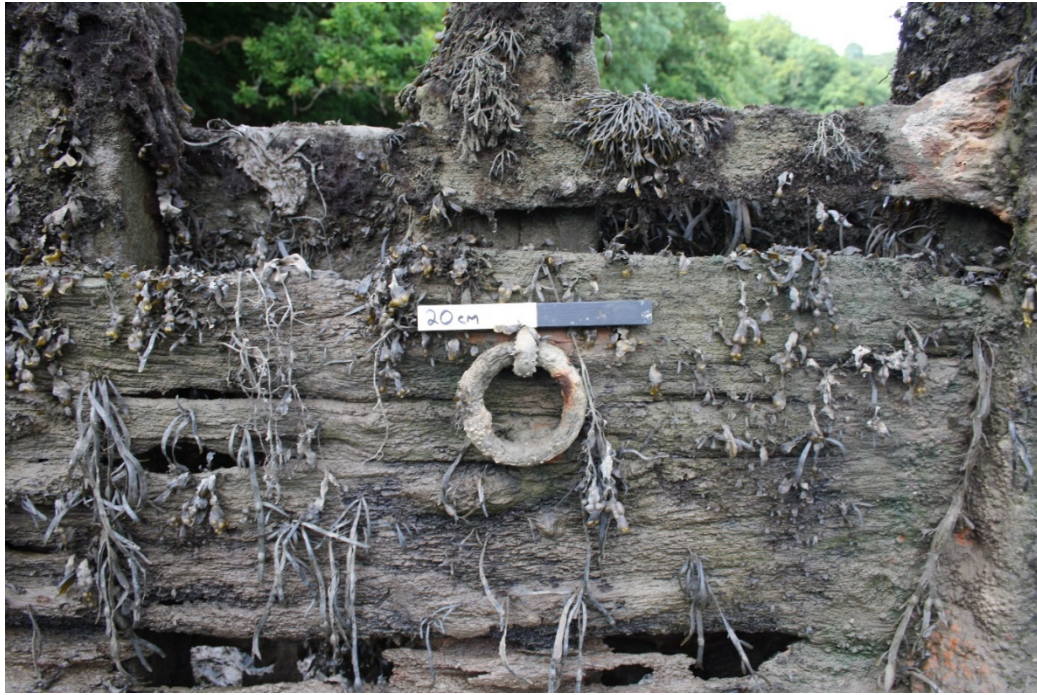
Internally there is a mooring ring set on the starboard side into the ceiling planking (Figure 21) presumably this came with a matching pair on the opposite side that has been lost, with the potential for further rings to have been situated in the bow and stern. The logical purpose of these rings is to secure cargo.

FIGURE 21 - INTERNAL MOORING RING

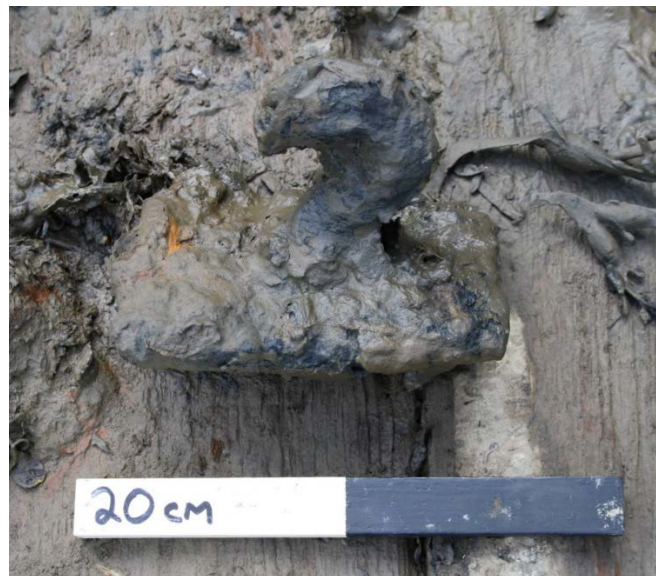
There are other various fittings within the hull remains but are no longer attached, that are highly likely to be associated with the vessel. A 20cm x 5cm hook which may have been mounted internally to secure cargo (Figure 22). A possible lodging knee is located in the site which is likely to be from the stern (Figure 23).

FIGURE 22- DETACHED HOOK, LIKELY TO HAVE BECOME DETACHED FROM THE STRUCTURE

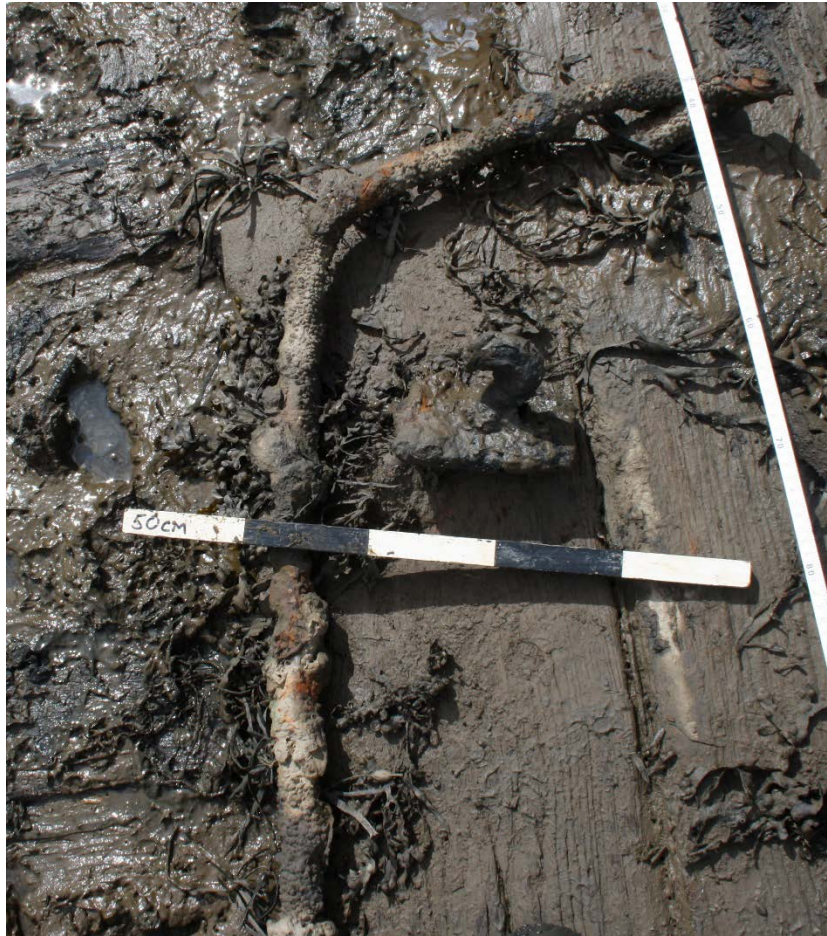
FIGURE 23 - POSSIBLE LODGING KNEE

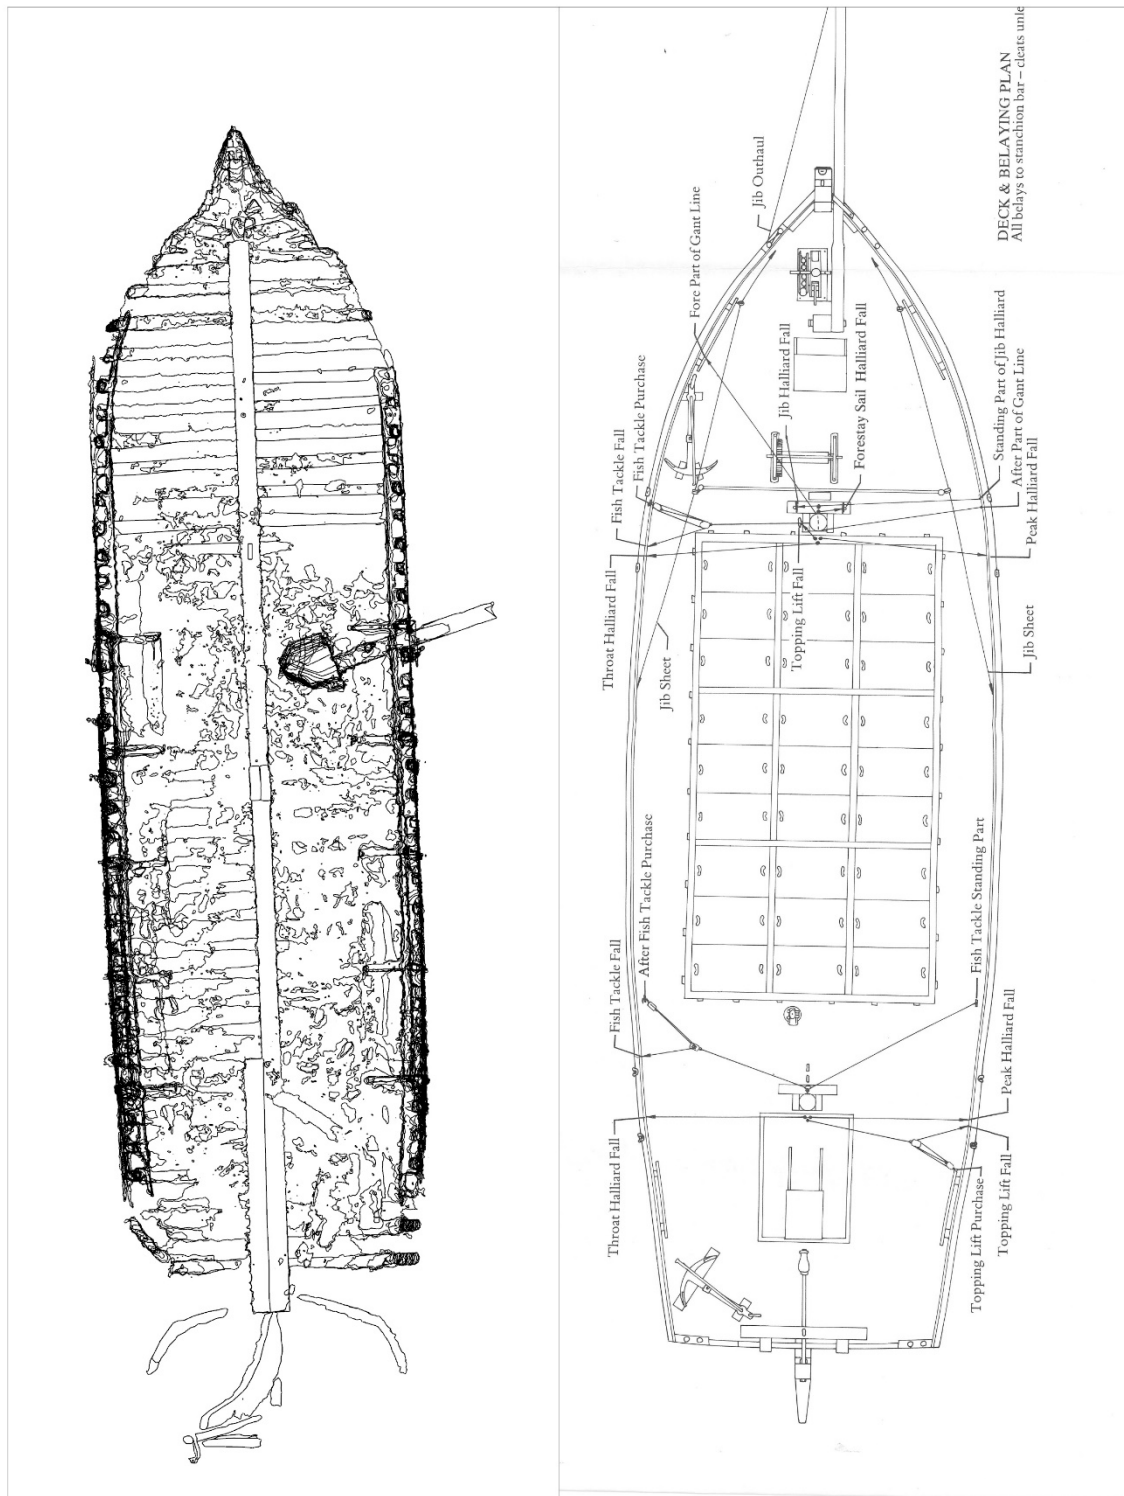
Comparison of the vessel remains with the Tamar barge *Shamrock* shown in Figures 24 and 25 show main similarities in form, although the *Lord John Roberts* is slightly smaller in length and breadth. The general layout and disposition of the structure would suggest the remain represent an Outer Tamar barge. While the identity of the vessel as the *Lord John Roberts* is not completely determined, at present time it is the most likely candidate.

Birds eye
 view of Site

Deck Plan
 of the Shamrock

FIGURE 24 - SITE PLAN OF THE LORD JOHN ROBERTS COMPARED TO THE DECK PLAN OF THE SHAMROCK TAMAR BARGE
